Preventive Conservation and Repair Work at Cibyra from 2010 to 2017

Esra SAYIN

Ünal DEMİRER

Citation E. Sayın, Ü. Demirer "Preventive Conservation and Repair Work at Cibyra from 2010 to 2017". *Phaselis* V (2019) 207-229 <http://dx.doi.org/10.18368/Pha.19014>

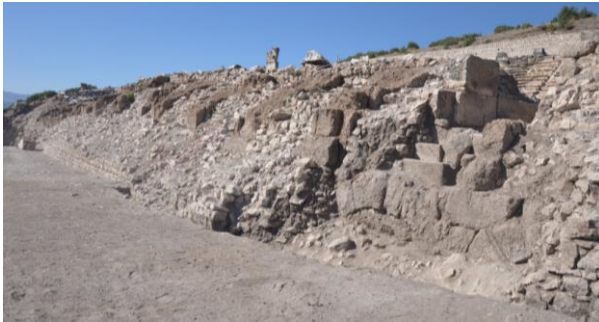
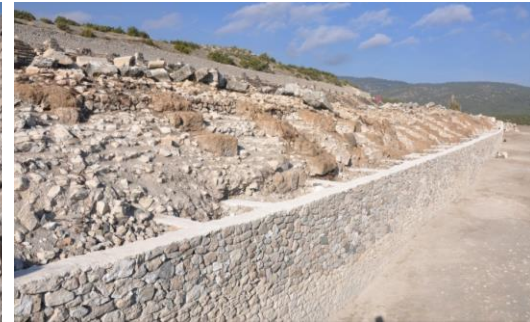
Fig. 1. Stadion retaining wall, before conservation
(Kibyra Excavation Archive)

Fig. 2. Stadion retaining wall, after conservation
(Kibyra Excavation Archive)

In the eastern part of the stadium, the deterioration of the retaining wall, which is parallel to the cavea and consists of rubble stones with lime additive, caused the need for repair and

anastylosis studies of the area in question⁸. In consequence, the inner cavea with the retaining wall to the east of the cavea, built to increase the resistance of the internal cell walls, were strengthened and at the targeted point the repair applications reached its goal. Thus, the retaining walls in the cavea and adjacent structures, which make up the eastern part of the building, have become protected and the structure has become an integral feature (Fig. 1-2).

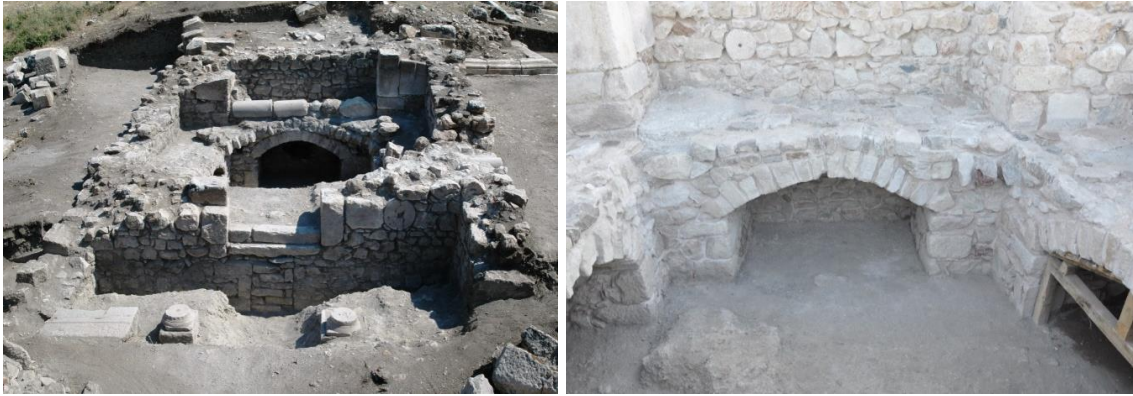
The martyrion, located to the east of the Propylon of the Stadion, experienced great damage when the propylon collapsed in a major earthquake. Despite this destruction, the main walls of the building, the vaulted tomb beds forming the grave chamber at the bottom and support of the upper floor were found to be quite intact (Fig. 3). Therefore, this structure with the architectural features of Late Antiquity of the city, with the necessary information concerning the heavily damaged Martyrion underwent urgent intervention and was taken under protection. In addition, the loss of the stone rows in the structure, the depressions and the deformation of the ruins constitute a risk factor affecting the soundness of the remaining parts, as well as disturbing the aesthetic appearance⁹. The aim was to protect the structure urgently within the scope of the conservation-restoration works of 2012 due to the fact that such deteriorations will increase in the process and will cause dangers that will manifest itself in new ruins¹⁰.

Fig. 3-4. Martyrion, before and after conservation (Kibyra Excavation Archive)

It was decided that the most effective solution for the deformation of Martyrion was the restoration of the joint fillings of the walls of the walls constructed with rubble masonry using lime additive mortar. With this in mind, mechanical cleaning applications of the areas where spills occur in the wall joints had priority. In addition, the removal of the rubble stones damaged by natural conditions in the upper part of the main walls of the building were within the scope of these pioneering works. With this, the first stage of the works, all the wall joints on the inside and outside of the structure were made ready to be refilled. The second stage of the works consisted of filling the wall joints with the lime-based mortar compatible with the original. The content of the mortar applied was hydraulic lime, 0-3 mm. The mortar comprised white sand, natural colorant and strength-enhancing sieved brick/tile powder, ready-to-use special masonry mortar and white acrylic. The obtained mortar was filled by pressing into all the wall joints prepared for application. In addition to this pointing application, a supporting wooden

construction was made, on the lower part of the vault in order to strengthen the vault of the door on the north facade which provides access to the lower burial chamber (Fig. 4). As a result of the conservation practices carried out, the building has become soundly integrated and has been made more resistant to natural conditions.

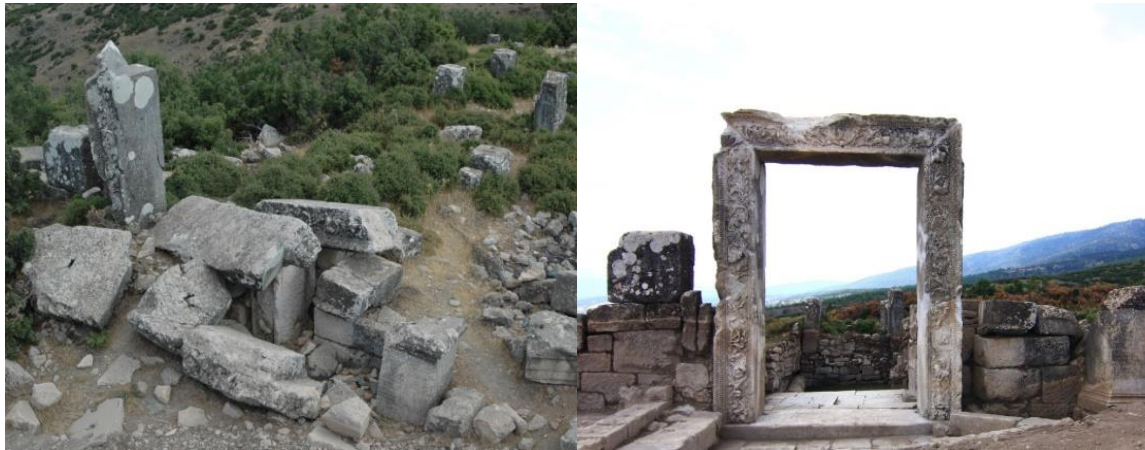
Excavations in Agora, which has an important position in the city where merchants and artisans offered their products for sale, began in 2009. For reason of its importance in this context, it was decided to raise the monumental gate in the northeast corner of Agora, which had been heavily damaged in the Late Antiquity, during the 2009 works¹².

Fig. 5-6. Monumental Gate, before and after conservation (Kibyra Excavation Archive)

As a result of the excavation workss carried out in the area, the eastern jamb of the door and the western jamb in the form of two pieces beneath the lintel were fully exposed (Fig. 5). These four parts of the door could be removed from the finds and repaired. The first step of the application was the integration of the western jamb weighing about 3.5 tons. Reinforcement of stainless steel or fiberglass rods (more commonly accepted) at certain points during the bonding of high and heavy loads is necessary for the durability of the process¹³. For this reason, the two main parts were repaired using three 18 mm. thickness and 40 cm. in length fiber rod bars and two-component epoxy-based resin¹⁴. After the lintel and jambs were assembled and

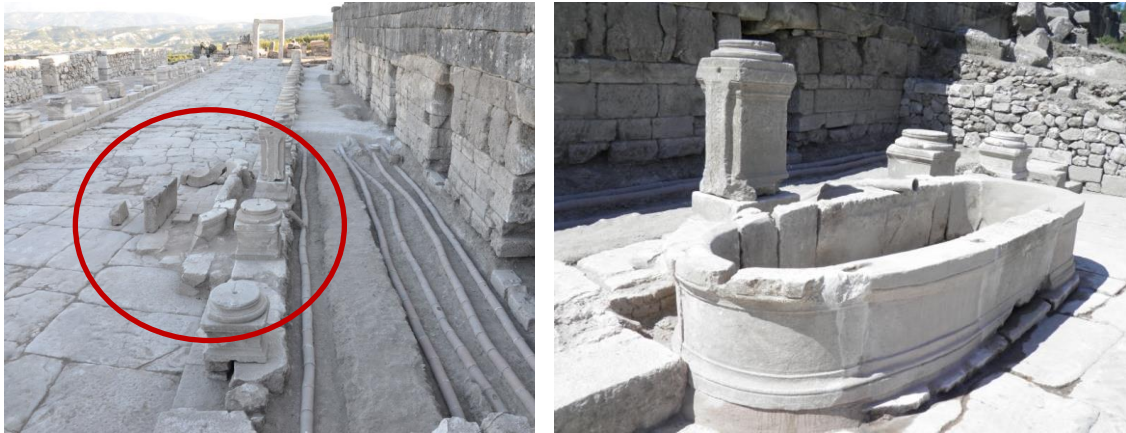
Fig. 7-8. Macellum, before and after conservation (Kibyra Excavation Archive)

Another conservation-repair work on the 1st Terrace Street in 2011 was carried out in the fish pond (Macellum) located on the 50th meter of the West Stoa. Located on the street between the 7th and 8th doors of the West Stoa, its outer contours measure 3.60 m. X 1.30 m. The repair work of the pool was measured by combining curved blocks of two parts at the south end. After the joining of the surviving parts, the missing parts on the two sides of the pool were completed by curving at the original angle for the purpose of integration (Fig. 7).

In order to retain the color and antique texture in these applications, in the hydraulic lime additive mortar a thick tile powder was used. In addition, in the integrated areas, the upper and lower profiles are partially machined in accordance with the *in-situ* parts, so that the integrity of the original parts and integrated areas is ensured. Following the integration of the outer contours, the brick work of the pool floor was re-arranged on the renewed floor with hydraulic doped lime mortar for the purpose of reinforcing, and in accord with the impressions marks on it and the missing parts were completed using the original material. In the final process, it was found that the line of pipe adjacent to the podium of the north-south axis postaments was connected to the pond through the original material uncovered by the excavations and thus the purpose of presenting the pool with its original appearance in antiquity was achieved (Fig. 8).

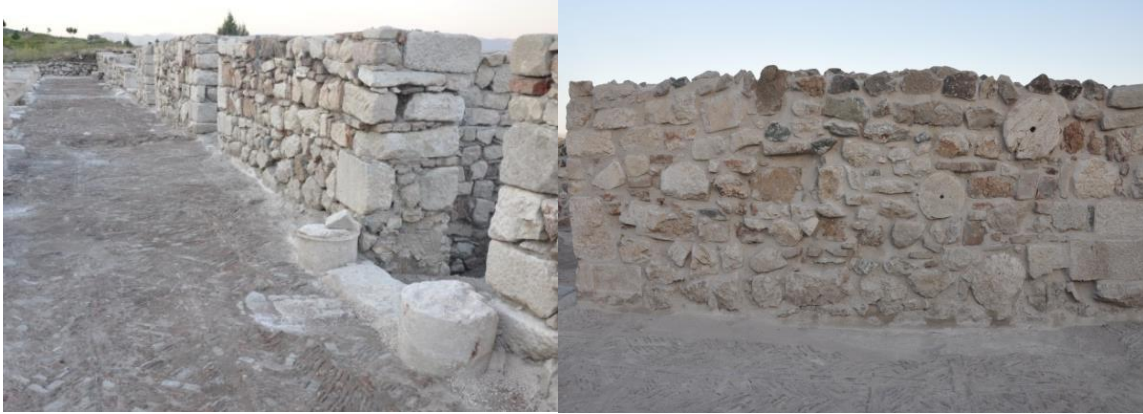
One of the protections and repair applications carried out in the 1st Terrace Street was conducted in the late antique shop walls in the East Stoa, from the year 2011 to the present day (Fig. 9). As a result of archaeological excavations, precipitations and debris formed by precipitation and external influences on the walls of buildings are frequently encountered in excavation areas. As a matter of fact, in buildings with such problems, completely or partially collapsed in the wall bonds which are exposed through excavation and when protective measures are not taken causes the loss of originality as a result of the loss of the bonding material¹⁶. In the shops of the Terrace Street, first steps were taken in order to prevent this deterioration. As a result of the strengthening of the rubble mesh walls to the protected level limited the destruction of the walls to minor rather than serious dimensions. Before conservation-repair works, not only the demolitions of the upper lattice of the walls, but also the joints made with the lime mortar between the rubble stones used in the walls were partially poured and the soil was filled in these parts. Therefore, the first stage of the work in the field of cleaning the soil between the joints and, at the same time, the risk of the falling out of the rubble stones were removed through cleaning the plant roots together with walls to be prepared for pointing.

Fig. 9-10. Late antique shop walls in east stoa (Kibyra Excavation Archive)

After these initial operations, in the second stage a highly qualified and high strength grouting mortar was prepared in accord with the lime mortar used in the building. The content of this mortar comprised: 0-3 mm. sintered crushing sand, hydraulic lime, bricks and tile shaft as colorant, white acrylic and strength fortifying mortar. After the dough prepared for the pointing application was pressed into the previously used grouting spaces, the settling time was expected to be completed. After that, the burrs were cleaned in the polishing process and the wall joints were given a natural appearance. At the same time in the upper part of the wall's deformation, fallen and scattered areas at risk, pointing protection was completed (Fig. 10). These conservation works carried out on the walls of the late-period shops were carried out systematically on those walls exposed as a result of excavations every year, and in consequence, the course of deterioration through exposure through excavation was impeded and the original form of the walls was restored.

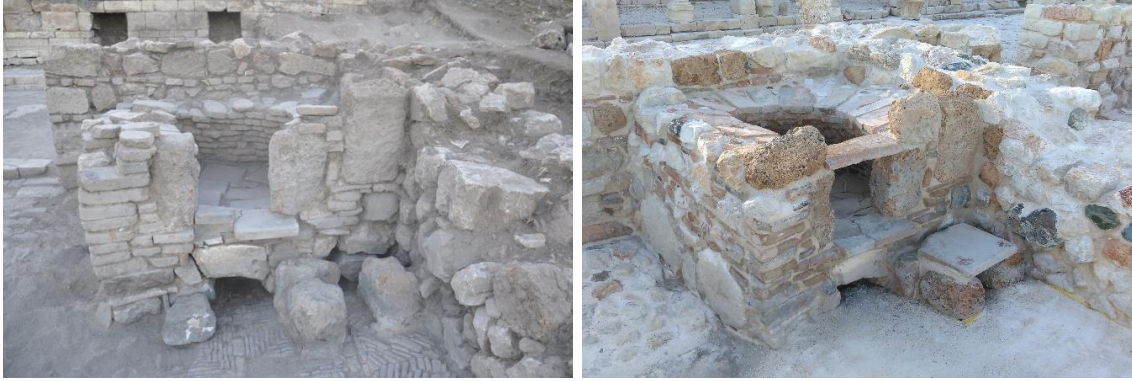
Within the scope of the 2014 conservation and repair applications carried out on the 1st Terrace Street, practices were carried out to increase the strength of the furnace located in shop no. 7 in the eastern stoa. In order to increase the strength of the structure of the furnace and to prevent the dispersion of the top cover system, operations began with documentation and photography. Then, as a preventive protection method for the joint problem observed in these types of structures, the old mortar, which had weakened in the joints of the bricks and the rubble stones, was cleaned with mechanical methods.

Fig. 11-12. Furnace, before and after conservation (Kibyra Excavation Archive)

Coarse aggregate and 1/3 ratio lime mortar was prepared for pointing applied to the joints by pressing. After completion of the pointing, the burring between the joints was removed by mechanical means. In addition to these operations, the upper part of the kiln was preserved with a new binding order employing its original material. As a result of the operation of protection and repair, the furnace structural problems were solved with the least possible intervention (Fig. 11-12).

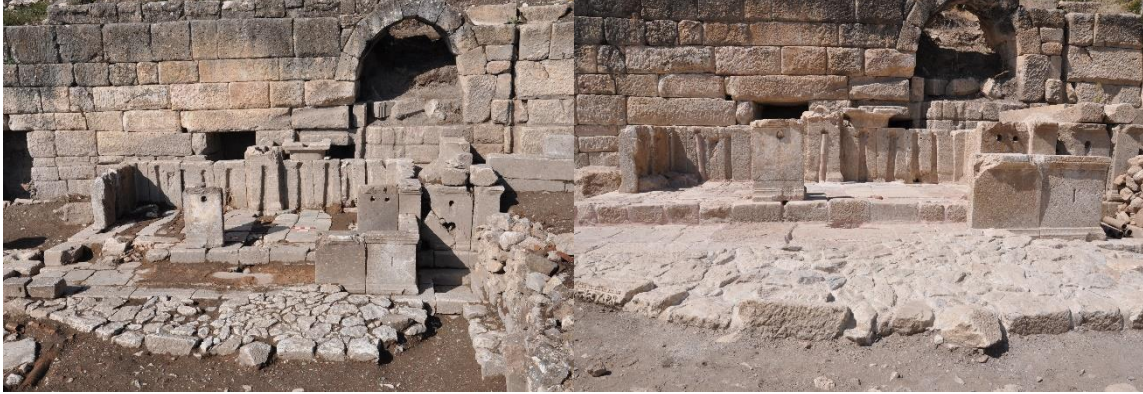
Fig. 13-14. Castellum/Nymphaeum, before and after conservation (Kibyra Excavation Archive)

Preventive protection and repair work was initiated in line with these objectives, the area was first documented by photographing the area and the first case distortion scale was removed. Following documentation studies, the first phase of conservation work initiated in the area was the repair of the parapet blocks surrounding the structure. During the mechanical cleaning applied to the parapet blocks, by using fine-tipped tools and compressors, the filling of

the surface cracks on the blocks and the spaces between the joints were cleaned and the fractures on these cracked blocks were determined. Then the broken pieces and broken blocks are glued into their original places with the help of a two-component epoxy-based resin. The joints between the parapet blocks were cleaned through mechanical cleaning and the cracks on the surface were filled with abundant water and filled with antique restoration mortar with a low mechanical strength.

After the passive protection applications to the parapet blocks, the floor blocks of the structure and the partial brick pavement in the floor were repaired. At this stage, the bricks that were heavily damaged in the broken brick flooring covering a part of the floor of the first pool were removed and replaced with amorphous bricks from the original material. The next stage of the floor conservation was cleaning the filling soil accumulated between the joints with the help of fine tipped tools and compressors. After cleaning, the floor joints moistened with plenty of water were then filled with a lime binding mortar. On the floor of the structure and the partially preserved coating mortar around the border mortar application of the existing plastered areas were prevented from their rupture, dispersion and loss, and the structure conserved with limited intervention.

Following the ground consolidation practices, the conservation-repair process of the partially preserved pipe rows in the western parapet walls of the first pool was initiated. In this work, the 4 pieces of pipe, which were seen to continue towards the grooves on the western parapet wall with the help of the elbow-shaped pipes, were raised into their original places and fixed to the parapet wall with the help of hydraulic lime-based mortar. In the other 8 grooves, the elbows were protected in their current state. This repair to the pipes is important for the visitor's understanding of the technology of the pool.

Initiated to conserve and preserve through the protection and repair applications carried out as described above, the resistance of the pool and the ponds connected to the pool to the adverse weather conditions of the winter months, minus temperatures, snow and ice, has increased and further deterioration from both the natural conditions on-site and visitors has been prevented. In order to enable the visitor to perceive the technical characteristics of the building, its visualization, the original material and the texture and the works were completed (Fig. 13-14).

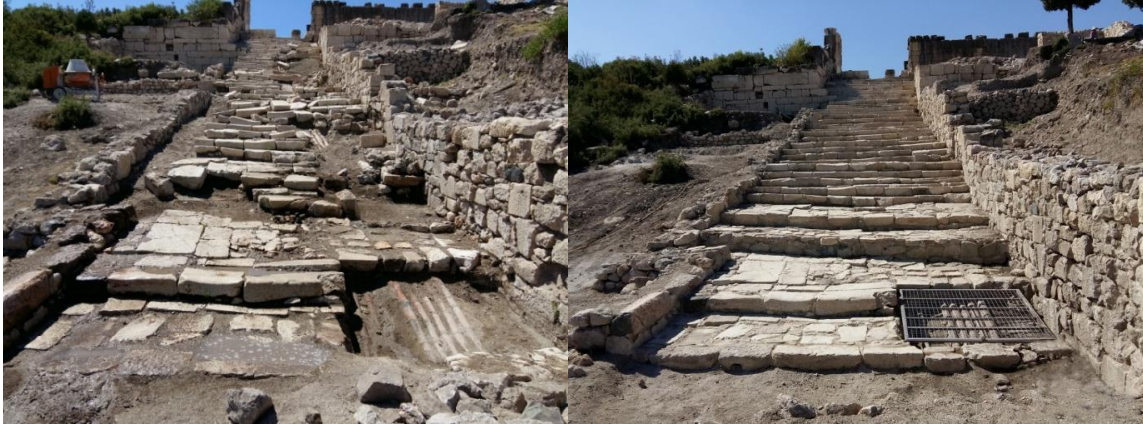
Fig. 15-16. Main Street, before and after conservation (Kibyra Excavation Archive)

Earthquake damage, the weather conditions and environmental factors resulted in ground movement and the distorted steps, and so, using the previously identified original blocks in accordance with the scientific rules with the application of anastylosis, a 1/3 ratio prepared with acrylic mixed hydraulic lime mortar employed for repair works. During this study, blockage was made in order to increase the strength of the lower part of the displaced step blocks and then the blocks were aligned to protect it against harsh climatic conditions, including ice expansion

In the first phase of the conservation-repair operations, those steps which have been heavily damaged in Late Antiquity and most of the blocks that had been removed and reused in different areas, were documented over previous excavation seasons. Then, the current situation determination of the distortions and documentation studies were carried out and protection-repair methods were then applied. The current number of steps is 35, each of which varies in size. The steps are different from those of the local limestone and the earthquakes, weather conditions and environmental impacts have resulted in abrasions to the surface, the formation of capillary cracks and the inevitable result of all these elements. In order to prevent further destruction of the blocks forming the steps by taking into account the negative factors on the material, the repair work began in parallel to the original building material of the Late Period wall structures extending in the east-west direction of the steps and which remained partially intact. In addition, the current state of the city's waste and clean water system, which lies in the east-west direction, has been preserved. Some of these protected areas were exposed to preventive protection measures in order to determine and display the city's sewerage and water system. Late period walls, which extend in the east-west direction, with irregular rubble stones and reused architectural pieces parallel to the stair steps, were reconstructed and reinforced in accord with the original through acrylic blended hydraulic lime mortar prepared in the ratio of 1/3 in the scope of simple repair work. The content of the mortar used in the application; 0-3 mm. under-sieve white sand, natural colorant and strength-enhancing property drawn 0-5 mm. sieved brick/tile powder, hydraulic lime, ready-mixed special building mortar and white glue (PVA) were included in the mixture. In addition, the distortions in the joints of the walls and in the stair treads were cleaned through mechanical methods and the original structure was maintained and repaired with hydraulic lime-based filler mortar with high strength used as the binding mortar.

and to prevent water leakage through the joint gaps. After these conservation operations, the areas of mortar application were soaked through the sprinkling technique for a few days to increase the strength of the mortar and to prevent cracking. Thanks to the protection, repair and anastylosis studies carried out on the stairs of the Agora 1st Terrace Street within the framework of scientific rules, the current state of the building was taken under protection and the structure was comprehensively understood and conserved (Fig. 16).

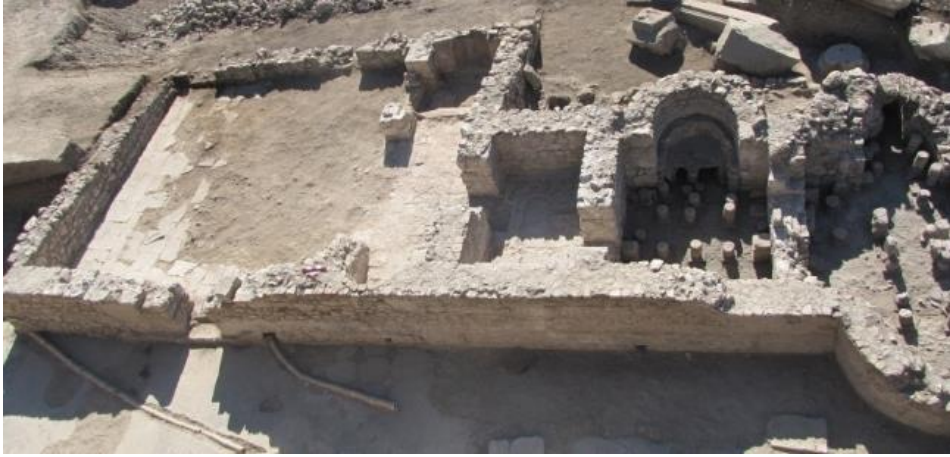
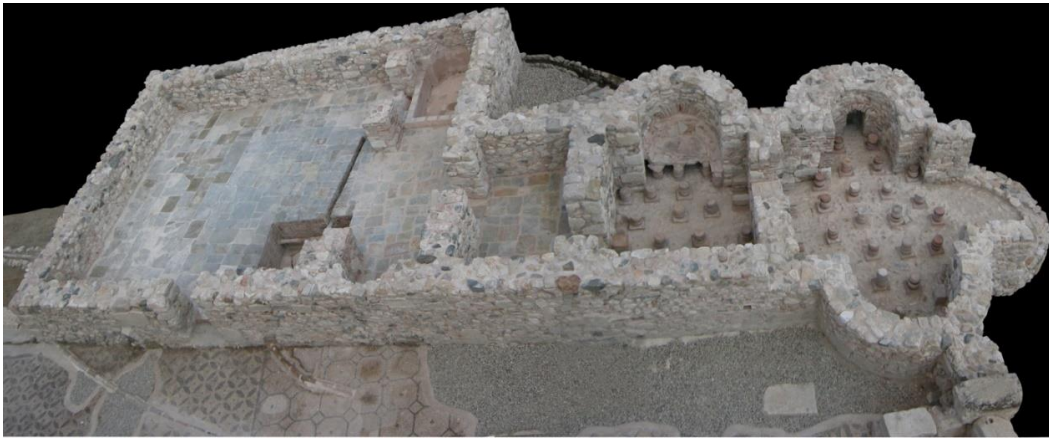
In those buildings where excavation works were completed, all the walls in the open air have been conserved in order to prevent the destruction seen in the joints and upper parts of the walls, which constitute the main plan of the building, with the understanding that if they remained unprotected, regardless of the materials with which they were constructed, they would deteriorate. The aim being to first protect and stabilize the outline of the structure. As in related areas work began with the cleaning out of grout mortars with low resistance, cleaning these parts with plenty of water and thus making them ready for pointing. The content of the mortar used in this repointing was: hydraulic lime, 0-3 mm. sieved white sand, natural colorant and strength-enhancing property drawn 0-5 mm. The tile shaft consisted of a special masonry building mortar and white acrylic, which were included in the mixture. This prepared hydraulic lime-based filler mortar was applied to the wall joints of the structure with a great care and then the grouting on the surface was cleared by mechanical means as the mortar reached optimum consistency. This pointing application was based on protecting the destroyed walls and has reduced the problem without causing any change in the original condition of the building, while the antique-natural appearance of the walls has been preserved.

Fig. 17-18. . Late Antique Bath, before and after conservation (Kibyra Excavation Archive)

The conservation and restoration work conducted in the Cibyra Late Antique Bath¹⁹ in 2012²⁰ were carried out in order to preserve and consolidate the building in its present state (Fig. 17). In order to maintain the originality and characteristics of the structure and to protect it with the least intervention, the necessity of repair applications in all parts including the caldarium, tepidarium, frigidarium, apodyterium and the main walls surrounding the structure was accepted and studies began with documenting procedures such as drawing and photography.

Following these documenting-conservation-repair operations, which were completed on the outlines of the building, conservation-repair work began in the main places that make up the bath. In this repair work priority was given to the Caldarium, to the floor of the field (hypocaust) and the columns (pilae) carrying the pilae supported floor of the structure. Because such materials are found to be more sensitive than architectural remains, because they have lost their support and protection when excavated, and because they are the elements that directly reflect the functions of the building sections²¹. Therefore, the pilae bricks, which were heavily damaged formed the first stage of the works initiated in order to protect the existing remains in-situ and prevent fresh deterioration, were removed from their places and thus the emptied hypocaust floor was reinforced by the re-blockage study. The large pilae bricks on this solid ground were placed in their original place by using the binding properties of the hydraulic lime-based mortar, taking into account the field drawings made over previous years.

In addition, a quadrilateral planned section was formed in the south-west corner of the room in order to expose the water system of the bath in the apodyterium and the water pipes were structured according to their direction. Thus, the water network system of the building is presented to the attention of the visitors in a clearer manner. Thus, the structure has been completely conserved against negative natural effects, the existing deterioration has been stopped and new deterioration has been prevented and the baths can be safely presented to visitors (Fig. 18).

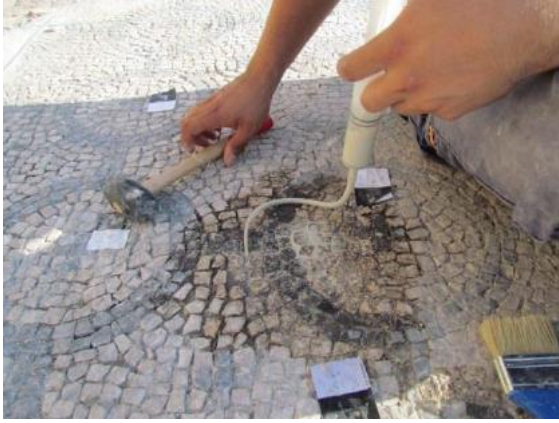
Fig. 19. Mosaic pavement of Odeion, injection
(Kibyra Excavation Archive)

After the injection studies, the border was applied to prevent possible dispersal of the environment and the loss of tesserae. In such studies, when selecting consolidation and curb mortars, materials that are closest to the original grout content should be used according to their thermodynamic property and water permeability. For this reason, the edge bands and end points 20 cm. width and 25 cm. a solid lime and a stone lime-based mortar were used to stabilize it. In order to withstand the mechanical stress caused by the climate, the material of Primal AC -33, which has the flexibility, was mixed with the mortar. This application is important in terms of forming the support that protects the existing tessellatum layer from the edges and ties it to the lower mortar layer. In order to prevent the loss of detail after the ground consolidation and border applications, the empty areas were completed with the original tessars recovered during the excavations. During this application, a mixture of hydraulic lime and Primal AC-33 based mortar was applied on the parts with a loss of tessera and the tesserae were arranged on the mortar.

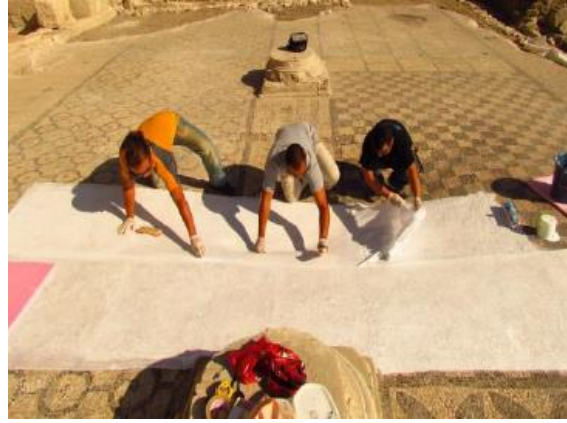
Fig. 20. Removal of collapsed areas
(Kibyra Excavation Archive)

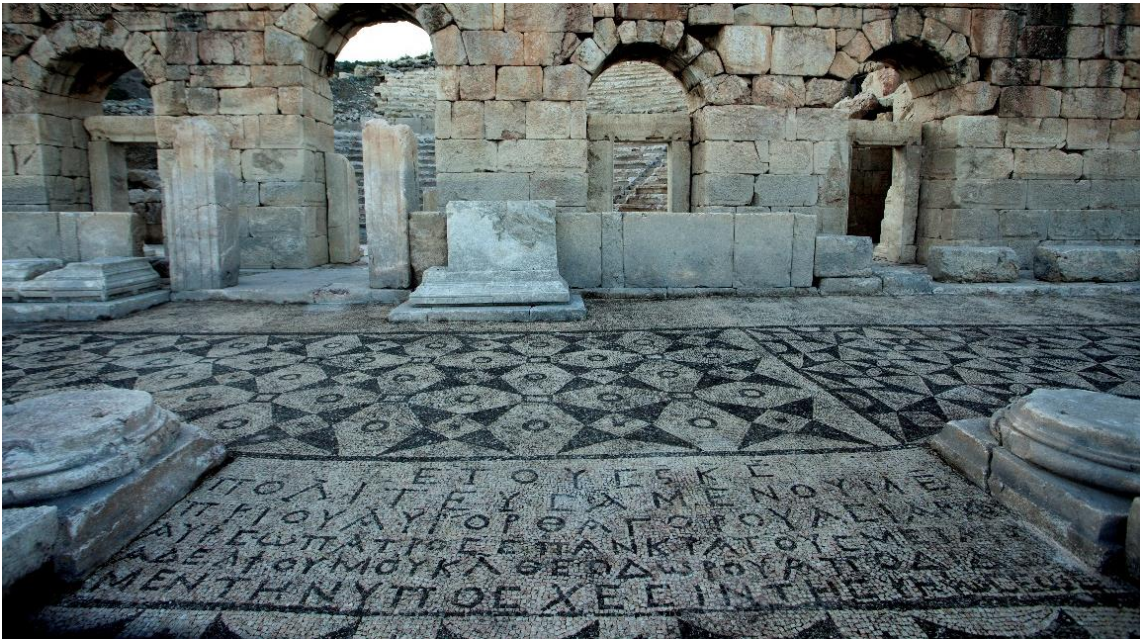
Fig. 21. Mosaic pavement of Odeion, after conservation (Kibyra Excavation Archive)

The last restoration practice in the area was the relocation of the collapse in the south wing of the mosaic and the place where the inscription was found. In this local application, 1/1 scale drawings of the collapsed panel were made and then PVA (polyvinyl acetate) was applied to the surface and the first layer was glued to the first layer and American cloth (thick white cotton cloth) was attached to the second layer (Fig. 20). The boundaries of the plates to be cut coinciding with the joints were cut off from the surface with diamond cutter wheels. Afterwards, the joints of the cut plates and the directions of the plates were drawn with acetate

pens on the American cloth and the surface was separated from the ground by long wedges. The old mortar, which has completely lost its bonding to the rear surfaces of these plates, was cleaned and made ready to be replaced again. As in the slabs, the floor, which was cleaned from rotten mortar, was prepared according to the original and was covered with the new mortar poured at the same level as the floor and the boards placed on this new mortar were leveled with the help of heavy trowels. At the last stage of the process, the cloths on the surface and PVA were cleaned through the application of hot water and the conservation operation ended (Fig. 21).

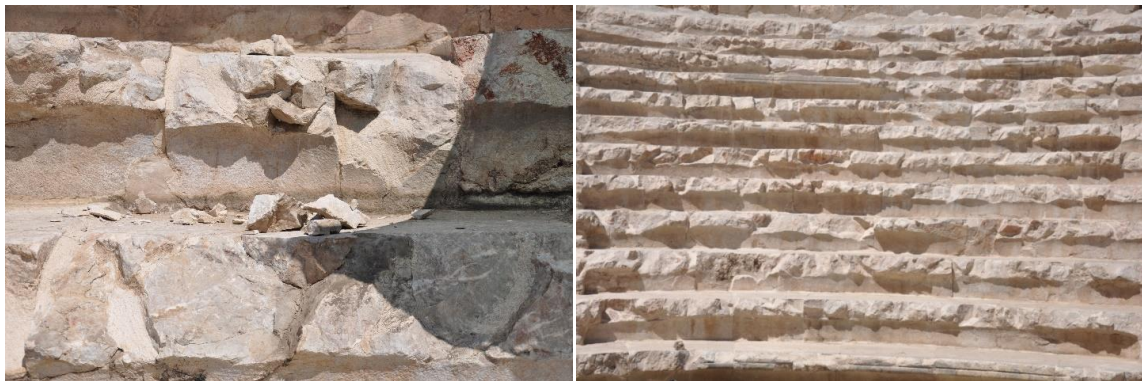
With the first observations in the area, it was found that severe cracks and deformations had occurred as a result of exposure to excessive heat in the blocks forming the rows of seats in connection with the loss of the function caused by a large fire in antiquity. In addition, water-wind erosion occurring in the soil for a long period of time, expansion and pulling movement due to extreme temperature changes, pressure resulting from the freeze-thaw cycle of moisture, 'water-soluble salts' solution in the stone and crystallization of physical degradation, amongst other factors²⁵. Therefore, the main purpose of the studies was to prevent the growth of the existing damages and the protection-repair applications were accordingly planned.

Fig. 22-23. Odeion Auditorium, before and after conservation (Kibyra Excavation Archive)

The first of the conservation studies was to fill the gaps in the interior of the stone by the cracks on the surface of the blocks. In this application, injection mortar, which has special properties, pozzolanic lime and micronized carbonates, which are suitable for the structural repair of masonry components, was used. Injected from all cracks, this fluid has the ability to fill the mortar up to the capillary cracks and so the penetration by water was prevented. After this preconcentration process, provided by injection applications, operations concerning the closure

of the surface cracks began. The mortar required to cover the cracks was prepared with great care and applied with the same attention. The content of the mortar used in the application; hydraulic lime, 0-1 mm. underglaze white sand, natural colorant and strength-enhancing property 0-1 mm. The sieved brick-tile powder contained special packaging mortar and white acrylic, which were included in the mixture. All the cracks and gaps on the blocks of the rows of seats were filled with this mortar and thus the water and air intake into the stonework was prevented, with homogeneity provided to the surfaces of the blocks and thus the possible mechanical demolitions and openings that could occur with water-ice expansion, especially in the winter months was prevented (Fig. 22-23).

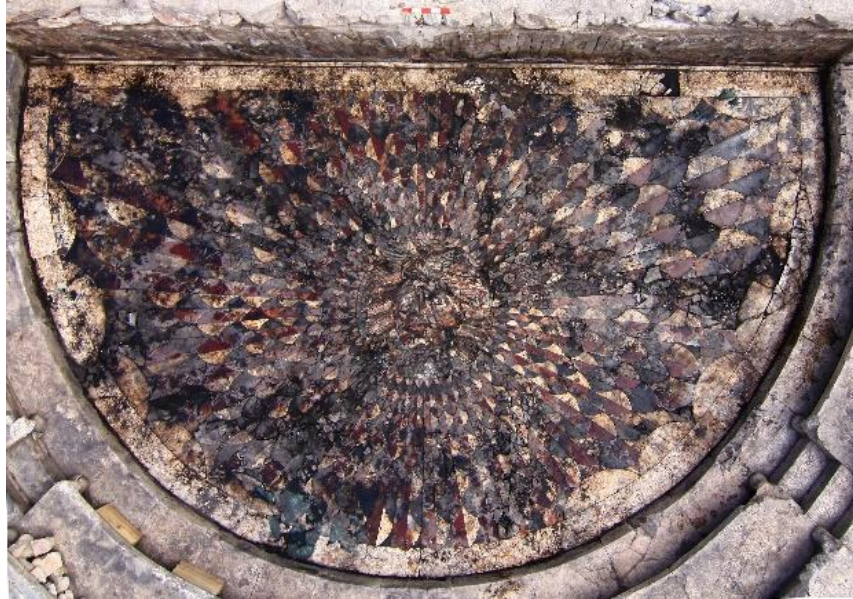
Fig. 24. Orchestra Opus Sectile Pavement, before conservation (Kibyra Excavation Archive)

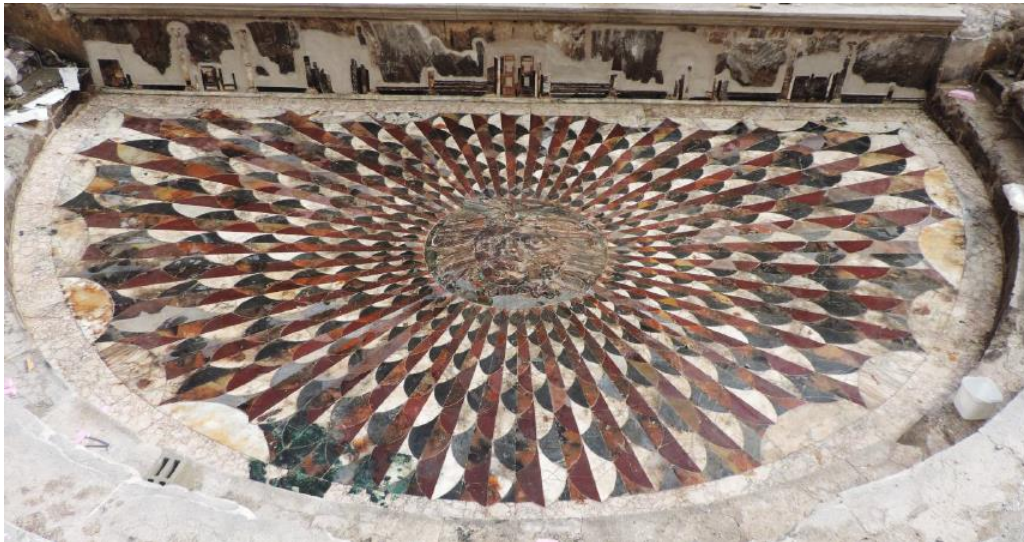
Res. 25. Orchestra Opus Sectile Pavement, after conservation (Kibyra Excavation Archive)

Afterwards, the parts were grouped according to their formal characteristics and found their own components and they were sorted into separate panels according to the parts they could belong to and their original positions were determined. With these parts found after the missing parts, in order to secure the *in-situ* parts in place and to be placed on a healthy floor,

firstly the fixation to the floor was made with the main floor. For this purpose, the parts of the soil plates, which were used as blockage together, were separated from the wall by stainless screws and attached to the main wall and the spaces between the wall and the block were injected. After the repairs to the weakened material texture of the assembled parts, this new ground was reinforced with hydraulic lime-based mortar and the integration and consolidation at the front were completed. Thus, the general appearance of the facade today reflects the visual appearance of the facade in antiquity²⁸ (Fig. 25).

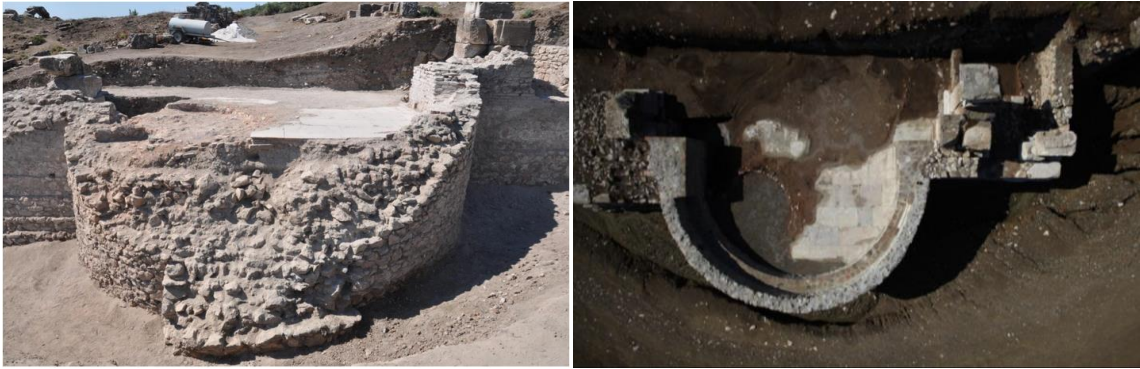
As a result of the excavations carried out in 2015, it was determined that there were serious physical disturbances in the apse and the main walls of the ambulacrum, which constitute the main structure of the bathhouse in the north west (Fig. 26). In addition, the first impression is that small-scale flooring marbles that can be preserved in the apse centre, the original plasters on walls, and skirting samples found on the apse are also greatly damaged. Considering all these destructions, a rapid and effective conservation-anastylosis study was inevitable in the field against all kinds of threats due to the difficult weather conditions that will especially occur in winter season.

Fig. 26-27. Roman Bath Complex, before and after conservation (Kibyra Excavation Archive)

With this in mind, the conservation works initiated in the area have been carried out primarily in the apse given its poor condition. Firstly, the walls to be protected and repaired were washed completely with clear water and then the brick wall which forms the eastern starting corner of the apse was raised to the original wall level and the wall was blocked behind and its connection with the main rubble mesh wall was ensured. In all wall bonding works in this area, original stones belonging to the structure were used. In the second stage of the studies, bonding work was carried out to the main apse wall. Particularly the wall, which was largely destroyed due to earthquakes, was considered as a necessary condition for the future of the building with upgrade work to be carried out. For this reason, the wall, which was built with rubble stones, was increased to the same level as the brick walls of the apse.

In the inner part of the apse, the sitting set was covered with bricks on the surface in accordance with the original, and the rough workmanship of this area was completed. In addition, the skirting examples found at the western end of the section were re-studied for consolidation. The final phase of the conservation work was carried out to the interior walls of the apse and on the internal walls. The mortar used in these operations was 0-4 mm. It consists of natural conglomerate shaft and hydraulic lime. First of all, the area has been completely protected, including the details of the plaster examples that can be preserved on the walls and then the outline of the small marble floor which was preserved on the apse floor (Fig. 27).

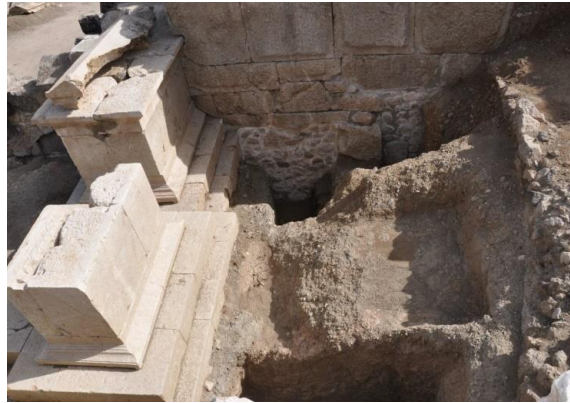
Fig. 28. Eastern Necropolis, retaining wall
(Kibyra Excavation Archive)

early period of the northern part of the necropolis, had to build a retaining wall in these areas due to the fact that the north wall of the monumental tomb placed on the grave tombs lost its static strength due to the base gap which was exposed after the excavations. For this reason, as a result of excavations, rubble stones were used and a masonry wall was constructed for safety purposes. The content of the mortar used in this wall, which is raised in a curved way from the grave floors to the bottom of the main wall; 0-6 mm. The natural conglomerate shaft, hydraulic lime and the natural colorant red clay soil which are included mixed with pure water were used. After the completion of the bonding process, the joints of the walls were pressed to make them look natural. (Fig. 28).

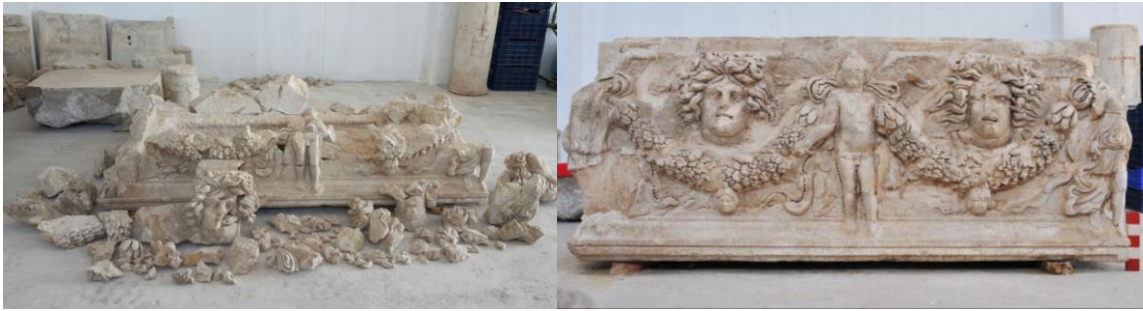
Fig. 29-30. Sarcophagus of Monumental Tomb, before and after conservation (Kibyra Excavation Archive)

The first stage of the conservation work on this sarcophagus comprised the integration of the front face which was preserved in broken pieces. During this process the original locations of the broken parts were identified and their location on the sarcophagus was determined. Then, the limestone layer and microbiological patina on the joint surfaces of the original parts were cleaned by mechanical methods and bonded to the fracture fracture by two component epoxy resin. The original parts of the sarcophagus were fixed to their original position on the sarcophagus using an epoxy resin. In order to prevent the excess resin in the joint surfaces from being elevated and to ensure that the alignment of the sarcophagus is not disturbed, the portions joined with the ratchet rope were compressed. The excess resin overlying the surface was cleaned with a diamond-tipped chisel and pure alcohol to provide structural integrity to the front surface of the sarcophagus. However, cracks and crevices should be covered with chalky mortar²⁹ if necessary. For this reason, it was ensured that the sarcophagus was restored close to its original appearance by applying the filling application to the cracks and to the damaged-lost areas on the surface (Fig. 30).

After the process of integrating the fractures on the front surface, which formed the first stage of the study, the complementary application to the two side surfaces, which are less conserved than the front face, have been applied in the same way.
