Case report: Total knee arthroplasty polyethylene liner disengagement identified by arthrography

David A. Bradshaw*, Brian Lam, Rebekah Hoffman, Bernard Zicat

Concord Repatriation General Hospital, Hospital Road, Concord, NSW, Australia

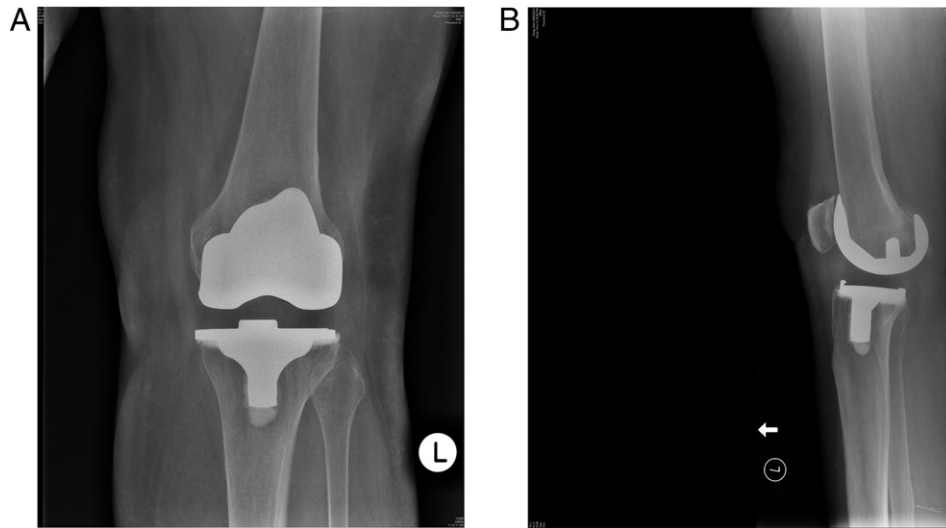
Plain film radiographs demonstrated a valgus deformity, with no radiographic suggestion of prosthetic loosening (Fig. 1). A technetium bone scan showed increased tracer uptake near the medial aspect of the femoral component, but this was not definitive for loosening.

Fig. 1. Pre-operative radiographic series: a) anteroposterior and b) lateral views.

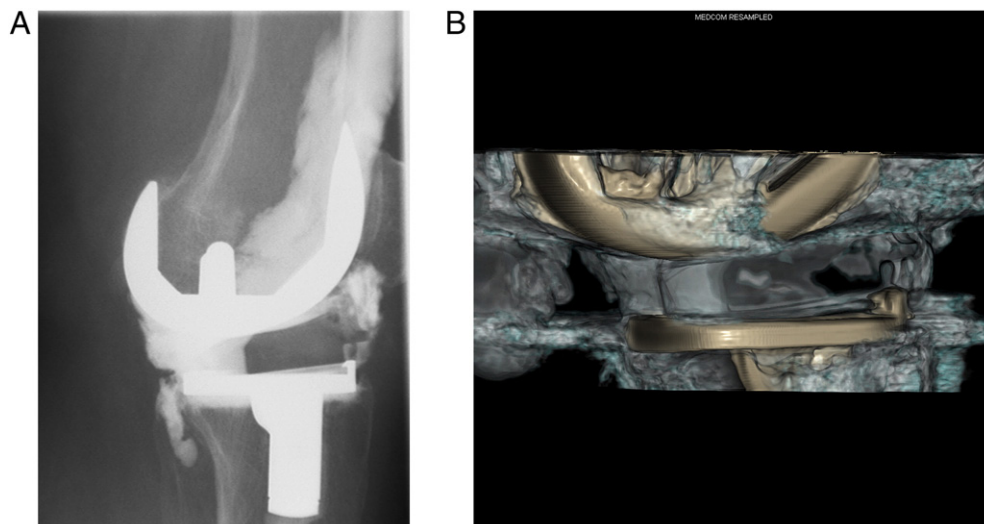
Both fluoroscopic spot-films and CT arthrogram demonstrated the polyethylene spacer perched on the anterior flange of the tibial component (Fig. 2). No contrast along the bone–cement or cement–metal interfaces suggestive of loosening was seen.

Fig. 2. a) Arthrogram demonstrating detachment of the anterior polyethylene locking mechanism; b) confirmed by CT arthrogram three-dimensional reformation.

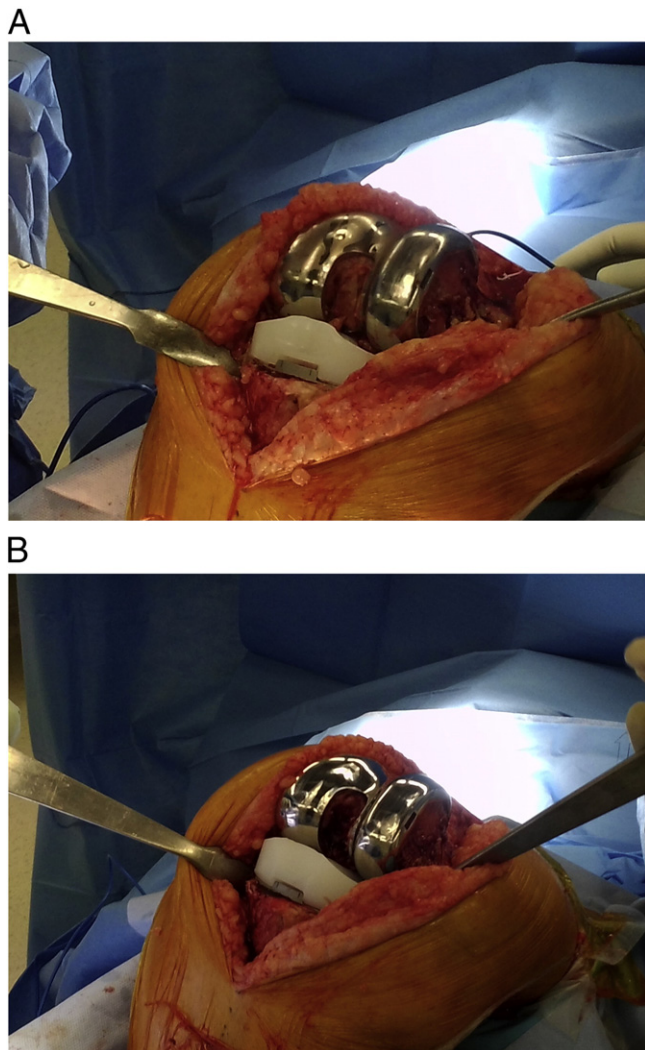
This arthrographic finding was confirmed during the revision operative procedure (Fig. 3). The anterior edge of the Duracon polyethylene liner's locking mechanism was not engaged in the tibial baseplate. There was focal wear of the posterior aspect of the liner, with macroscopic polyethylene debris in the joint.

Fig. 3. Intra-operative photographs demonstrating a) the polyethylene liner disengaged from the tibial baseplate; and b) the new polyethylene liner successfully engaged in the tibial baseplate.
