Chapter 1 Introduction to Geological Hazards in the UK: Their Occurrence, Monitoring and Mitigation

From: GILES, D. P. & GRIFFITHS, J. S. (eds) 2020. *Geological Hazards in the UK: Their Occurrence, Monitoring and Mitigation – Engineering Group Working Party Report*. Geological Society, London, Engineering Geology Special Publications, **29**, 1–41, <https://doi.org/10.1144/EGSP29.1>

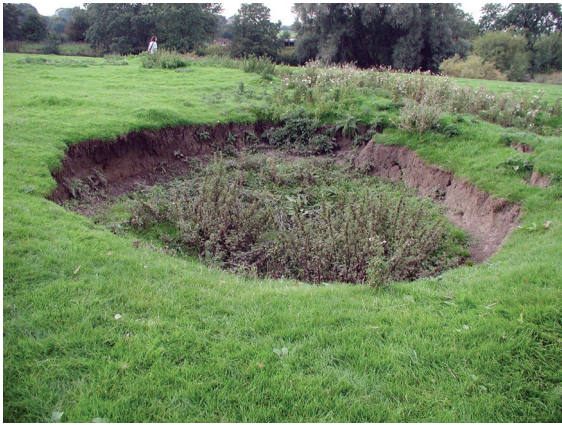
Fig. 1.2. Sinkhole development near Ure Bank Terrace, Ripon, North Yorkshire (photo credit: David Giles).

The area in and around Ripon is significantly affected by the presence of gypsum, hydrated calcium sulphate ($\text{CaSO}_4 \cdot 2\text{H}_2\text{O}$), in the local Permo-Triassic bedrock. A substantial number of sinkholes have developed in the area caused by the dissolution of the gypsum and the formation of gypsum karst. Subsequent collapse of these features (Fig. 1.2) has

led to considerable structural damage to buildings in the city (Cooper 2007).

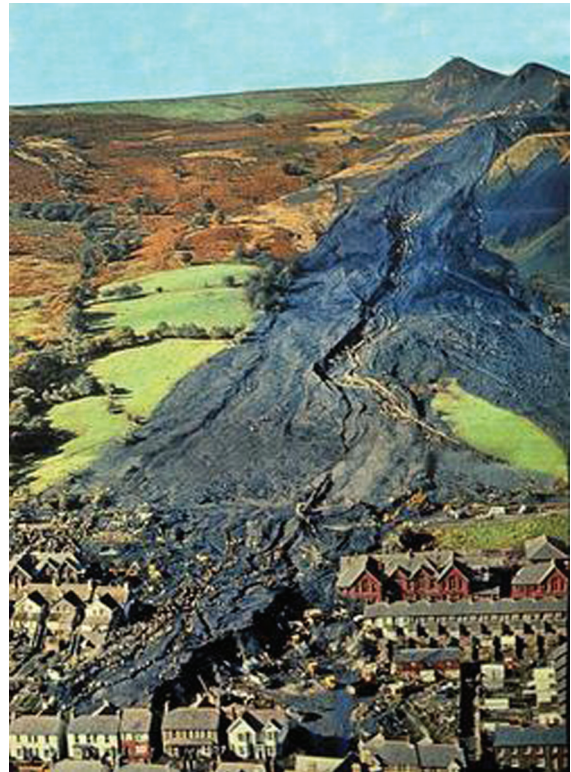
Fig. 1.3. Aberfan in the days immediately after the disaster, showing the extent of the spoil slip (<https://en.wikipedia.org/w/index.php?curid=54882575>).

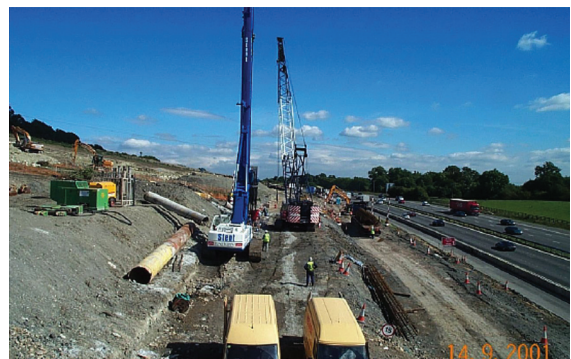
Fig. 1.4. Flint Hall Farm site works impacted on M25 carriageway (Griffiths & Giles 2017).

On 19 December 2000, during one of the wettest UK winters on record, a 200 m long section of the Flint Hall Farm cutting on the M25 failed and threatened to close the motorway, which carries over 120 000 vehicles a day (Fig. 1.4). Further rainfall triggered additional movements during

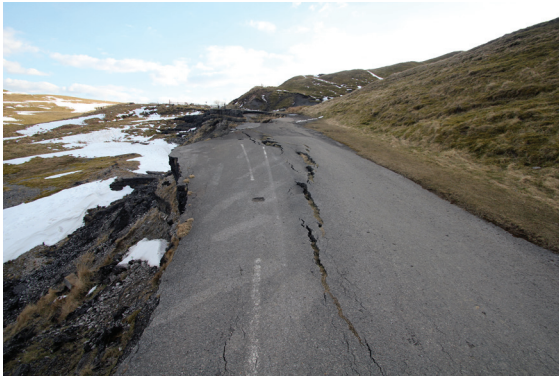
Fig. 1.5. Damage to the A625 carriageway by the Mam Tor landslide, Derbyshire (photo credit: David Giles).

rainfall and freeze–thaw action during the Devensian. The landslide was the subject of intensive investigations due to the damage that the slope instability was causing to the A625 road that traversed the landslide’s displaced material (Fig. 1.5). The road has been closed since 1979 (Waltham & Dixon 2000; Griffiths & Giles 2017).

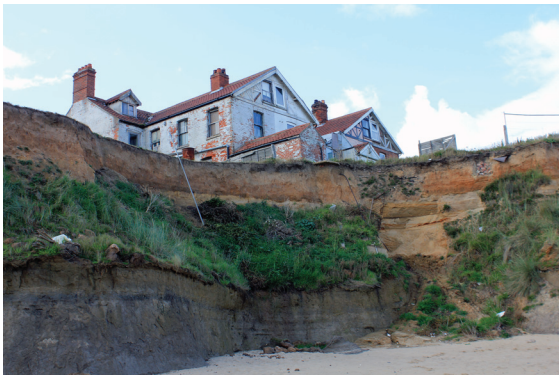
Fig. 1.6. Erosion on the North Norfolk coast, an example from Happisburgh (photo credit: David Giles).

The UK coastline has always been prone to erosion and major landslide events, affecting both property and land. Classic examples include the Undercliff, Isle of Wight (e.g. Moore *et al.* 2010), Happisburgh, Norfolk (e.g. Poulton *et al.* 2006) (Fig. 1.6), Black Ven, Dorset (e.g. Brunsten & Chandler 1996), Fairlight Glen, East Sussex (e.g. Moore 1986; Moore & McInnes 2011), where each location is influenced by the site-specific lithologies present.

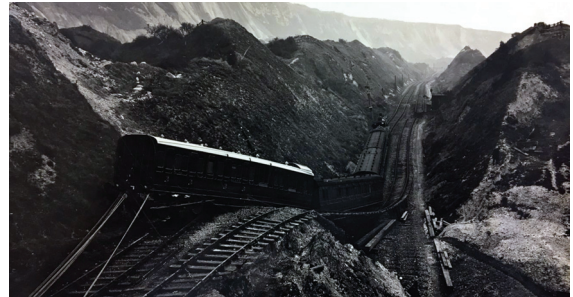
Fig. 1.7. Landslide at Folkestone Warren, Kent, 1914 (photo credit: Network Rail).

multiple retrogressive, compound mechanism, having translational, rotational and graben features. A major reactivation occurred throughout the complex in 1915 (Fig. 1.7), seriously disrupting the railway constructed in 1844 (British Geological Survey n.d.; Hutchinson 1969, 1988; Hutchinson *et al.* 1980; Trenter & Warren 1996; Warren & Palmer 2000).

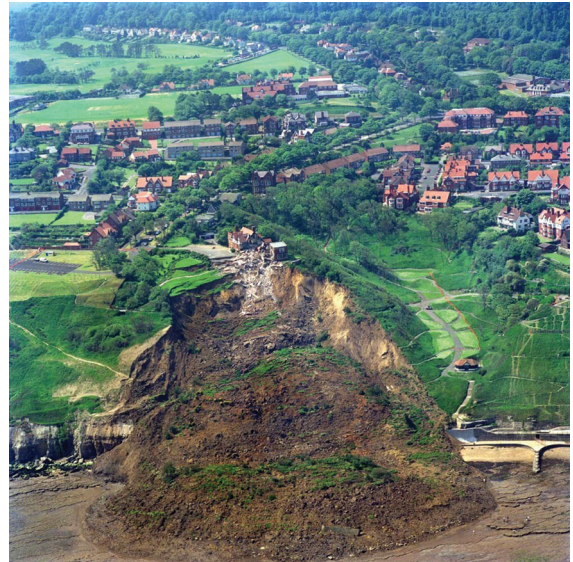
Fig. 1.8. Landslide at Holbeck Hall, Scarborough, Yorkshire, 1983 (photo credit: British Geological Survey).

The Holbeck Hall landslide destroyed the Holbeck Hall Hotel between the night of 3 June and 5 June 1993 (Fig. 1.8). A rotational landslide developing into a flow involving c. 1 Mt of glacial till cut back the 60 m high cliff by 70 m. It flowed across the beach to form a semi-circular promontory 200 m wide, projecting 135 m outwards from the foot of the

cliff. The likely cause of the landslide was a combination of rainfall (140 mm in the 2 months before the failure took place), issues related to slope drainage and porewater pressure build-up in the slope, all influenced by the site geology ([British Geological Survey n.d.](#); [Forster 1993](#); [Lee 1999](#); [Forster & Culshaw 2004](#)).

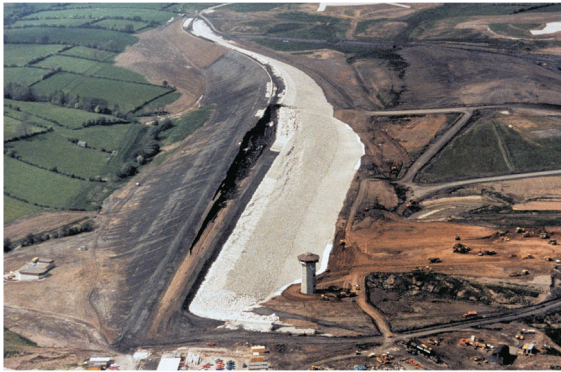
Fig. 1.9. Carsington embankment under construction in 1984 (photo credit: [Winter et al. 2017](#)).

An embankment dam was to be constructed 3 km south of Carsington ([Fig. 1.9](#)). An extensive ground investigation was carried out, but failed to recognize relict periglacial features that were present in the ground profile. Consequently, the embankment failed during construction in June 1984 and then had to be demolished and rebuilt to a design based on the correctly understood ground conditions. The reconstruction was successfully completed, but at a considerable cost and delay. The finished reservoir opened in 1992 ([Skempton & Vaughan 2009](#); [Martin et al. 2017](#)).

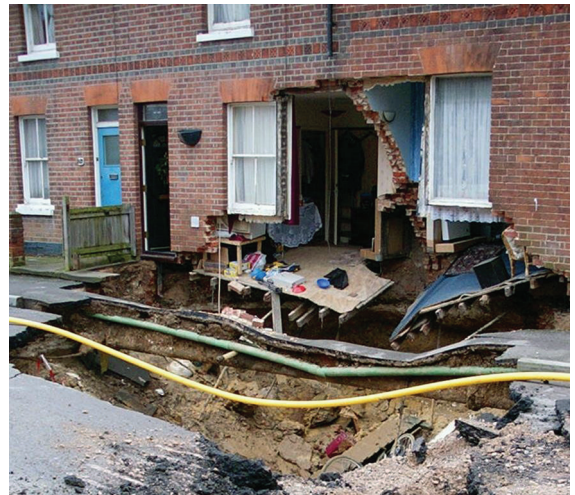
Fig. 1.15. Major subsidence through chalk mine crown hole collapse, Field Road, Reading, Berkshire (photo credit: Clive Edmonds).

In January 2000, several cavities of a nineteenth century chalk mine collapsed causing major subsidence of the

overlying ground around the Field Road (Fig. 1.15) and Coley Road areas in Reading. Thirty homes were immediately evacuated for residents' safety, with two homes later collapsing. The mines were remediated over a 12-year period

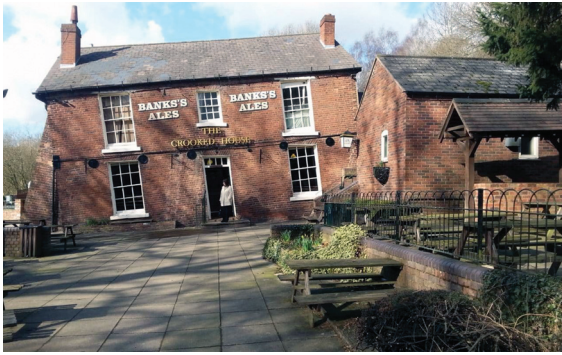
Fig. 1.16. The Crooked House, Dudley, suffering from coal mining subsidence.

There are numerous examples of hazards related to deep mines across the UK, and a notable accident associated with the coal mining industry occurred on 30 April 1945 (Fig. 1.16). *Dolly* was an engine that shunted coal wagons between the Maypole and Mains collieries in Wigan, driven by Mr Ludovic Berry. On the day of the accident, a large hole appeared in the ground under the railway lines between Abram and Platt Bridge. With the lines now unsupported they failed under the weight of the first wagons, causing them to plummet into the ground, taking the remaining wagons and *Dolly* with them. Ludovic, who tried to save the engine until it was too late to jump, lost his life. The hole had occurred as a result of the subsidence of a shaft sunk 60 years previously and sealed in 1932. The subsidence may have been the result of heavy rains in an area with many mine workings close by (Winstanley *n.d.*; K. Nicholls, pers. comm., 2019).

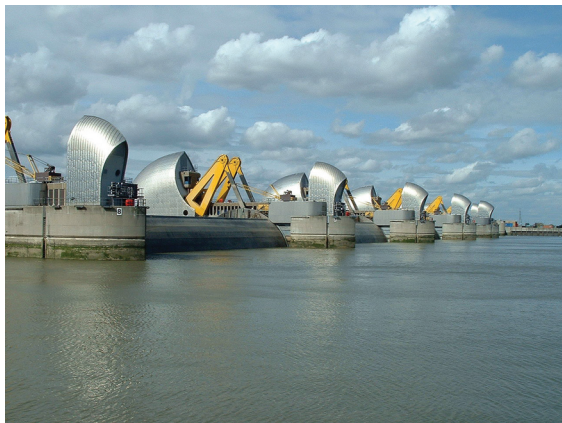
Fig. 1.18. Thames Barrier, London (photo credit: Andy Roberts).

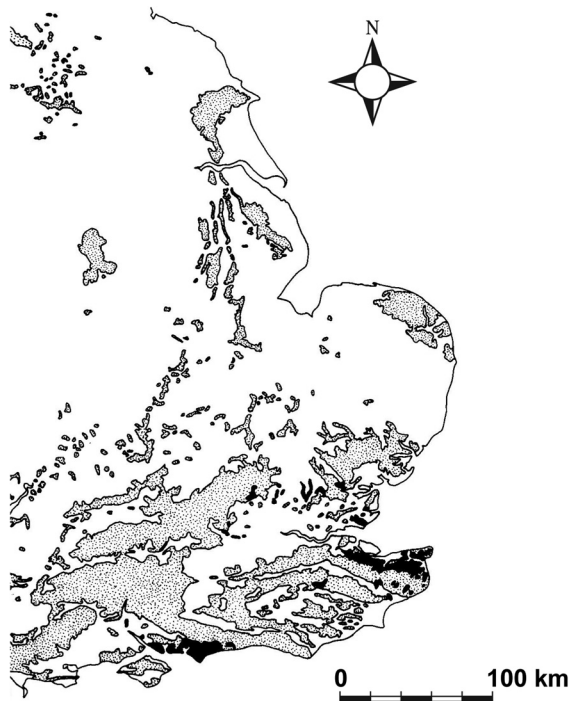
Fig. 1.24. Surface distribution of loess/brickearth in south UK based on Soil Survey 1:250 000 scale soil maps (1983). Loess >1 m thick in black; loess >300 mm thick (and often partly mixed with subjacent deposits) shown stippled (Culshaw *et al.* 2020).

some artificial non-engineered fills can also collapse. The main type of collapsible soil in the UK is loess, although collapsible non-engineered fills also exist. Loess in the UK can be identified from geological maps, but care is needed because it is usually mapped as ‘brickearth’. This is an inappropriate term and it is suggested here that it should be replaced with the term ‘loessic brickearth’. Loessic brickearth in the UK is found mainly in the SE, south and SW of England, where thicknesses greater than 1 m are found. In Great Britain, loessic deposits are mapped by the British Geological Survey mainly as ‘brickearth’. Such deposits occur mainly as a discontinuous spread across southern and eastern England, notably in Essex, Kent, Sussex and Hampshire (Fig. 1.24).

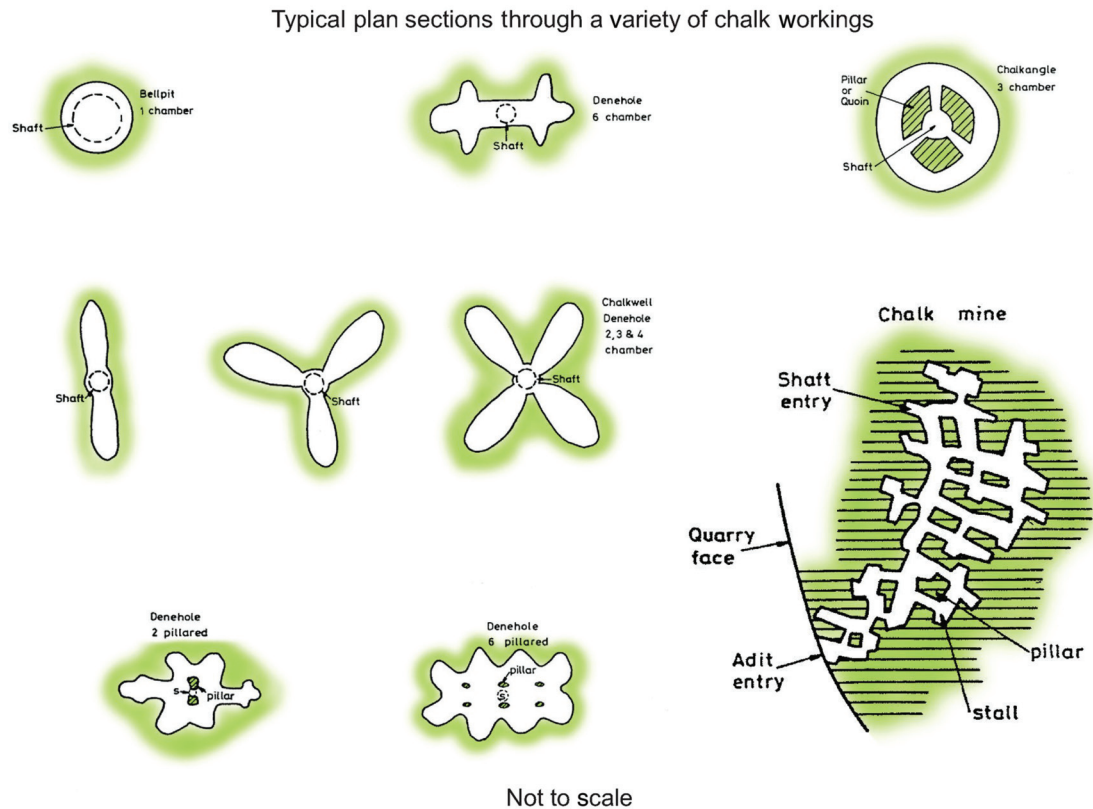
Fig. 1.29. Typical schematic plan sections through a variety of chalk mine workings (Edmonds 2020b).

and the oldest chalk mines from at least medieval, possibly even Roman, times. The most intensive period for mining was during the 1800s, although some mining continued into the 1900s. The size, shape and extent of the mines vary considerably, with some types being found only in particular areas. They range from crudely excavated bellpits to more extensive pillar-and-stall styles of mining (Fig. 1.29). The mines were created for a series of industrial,

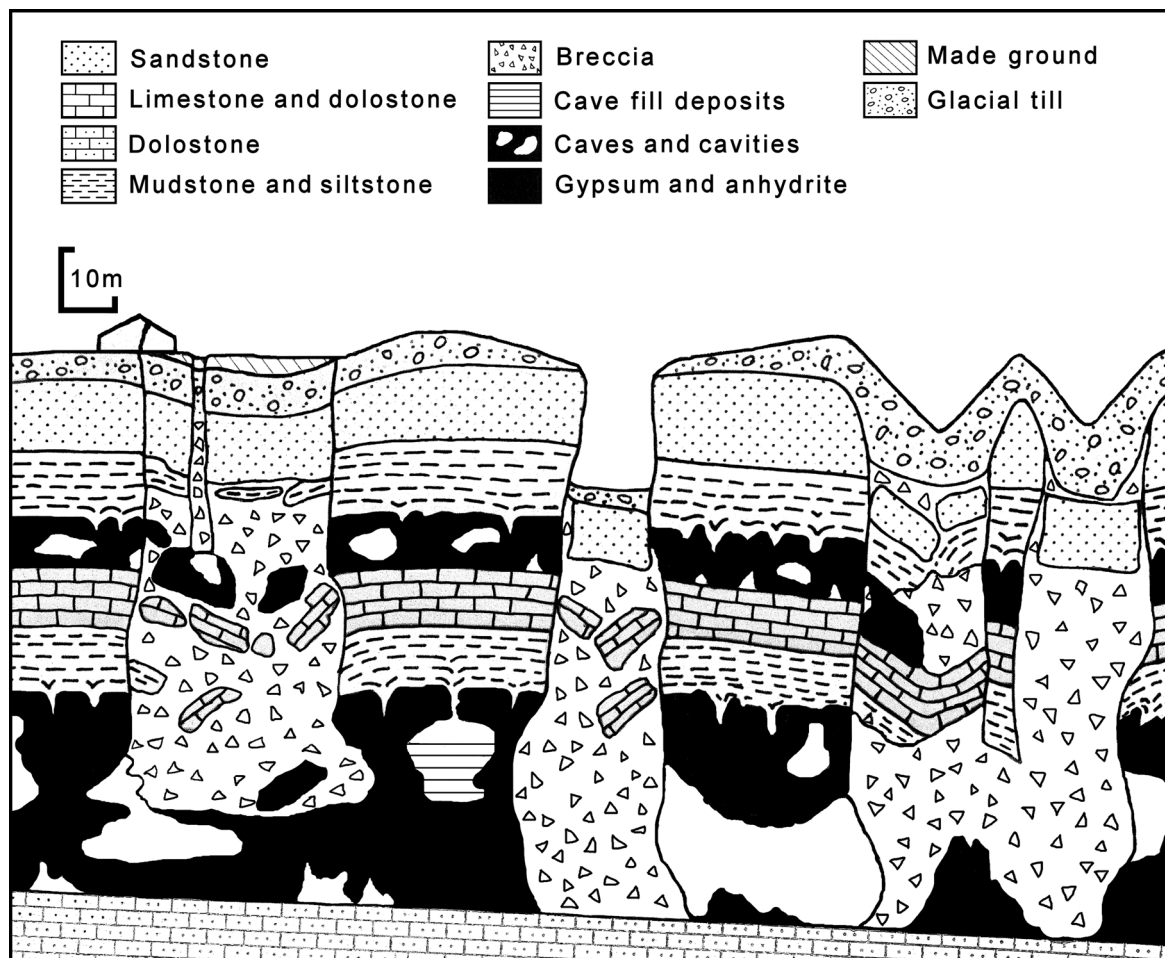
Fig. 1.34. Stylized cross-section through gypsum dissolution subsidence features in the east of the Ripon subsidence belt (Cooper 2020a).

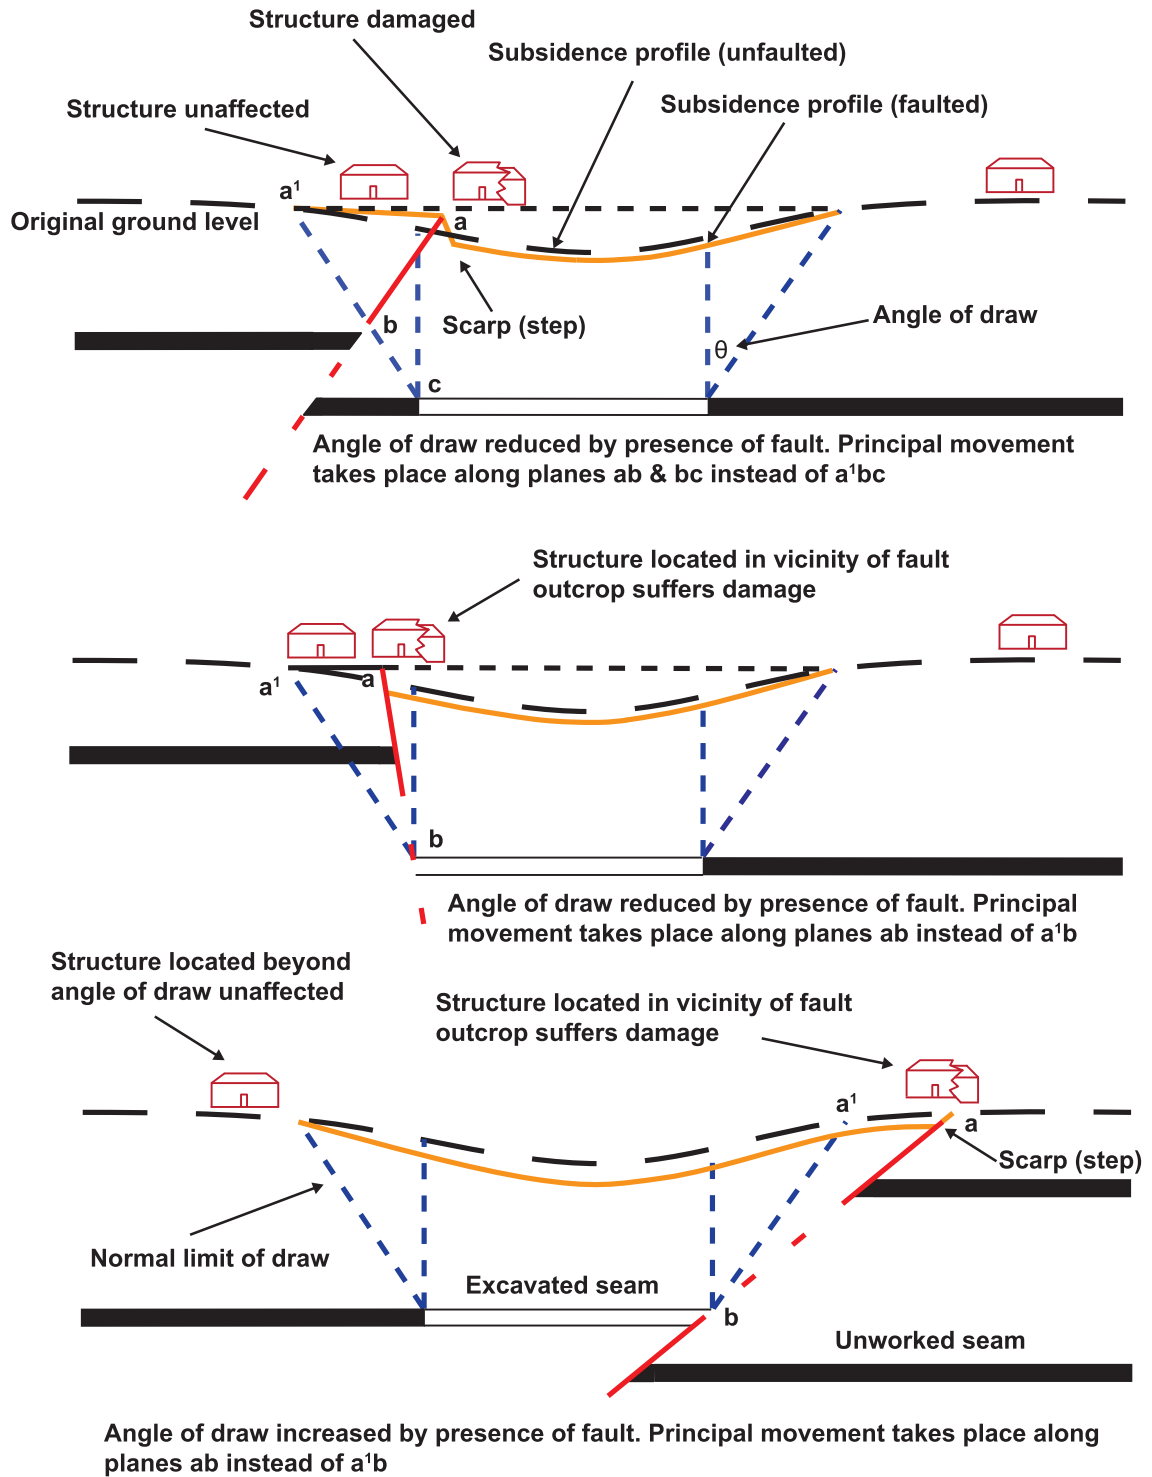
Fig. 1.35. The influence of faults on mining subsidence and the angle-of-draw (Donnelly 2020a).

Faults are susceptible to reactivation during coal mining subsidence. The effects may be the generation of a scarp along the ground surface, which may or may not be accompanied by associated ground deformation including fissuring or compression. Reactivated faults vary considerably in their occurrence, height, length and geometry. Some reactivated faults may not be recognizable along the ground surface, known only to those who have measured the ground movements or who are familiar with the associated subtle ground deformations. By comparison, other reactivated faults generate scarps up to several metres high and many kilometres long, often accompanied by widespread fissuring of the ground surface. Reactivated faults induced by mining
