FULL SCALE FATIGUE TEST OF NEW UNDERCARRIAGE FOR COMMUTER AIRCRAFT

Polskie Zakłady Lotnicze Sp. z o.o., Mielec

Abstract

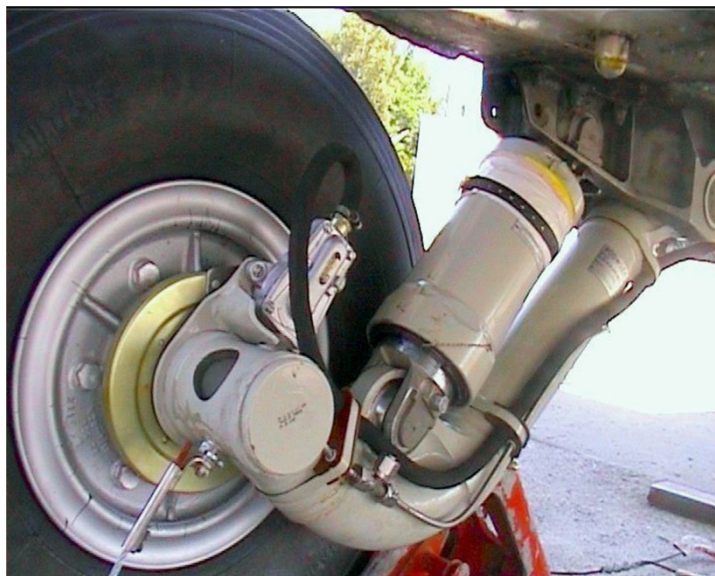
Fig. 1. The new main landing gear of PZL M28 aircraft

The main landing gear is of an articulating type with a braked wheel. It is mounted at the ends of the main landing gear beam, which is part of the fuselage structure. The main parts of the landing gear are:

- leg – see Fig. 2;
- oleo-pneumatic shock absorber – see Fig. 3;
- wheel axle;
- wheel with a brake.

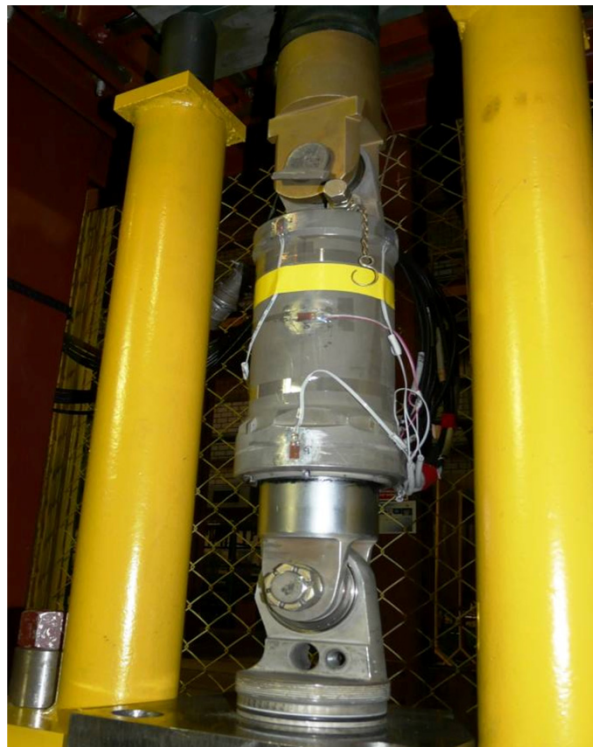
Fig. 8. The modified shock absorber on a stand during fatigue testing

It was determined to continue the test for the landing gear with a mock-up shock absorber, in order to gain time to develop and introduce design changes to the shock absorber. The modified shock absorber was tested at a separate rig – see Fig. 8. Only one loading channel was required ([4]). The axial force spectrum from the Full Scale Fatigue Test was applied – see Fig. 9.

Ten strain gauges were installed on the cylinder in order to check the calculated stress levels and monitor the structural integrity at the most heavily loaded places.

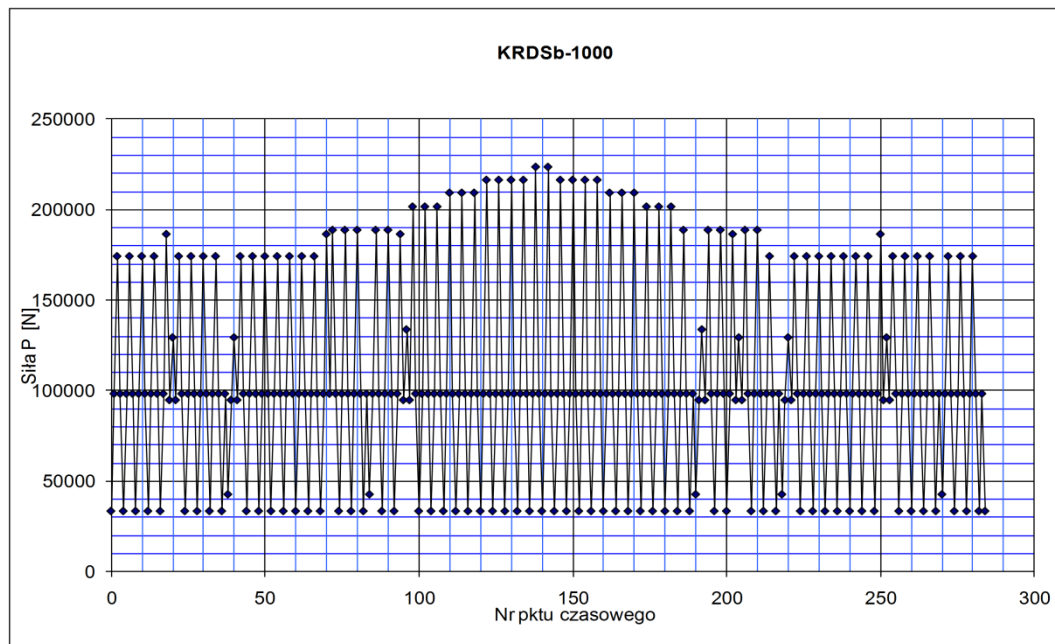
Fig. 9. The axial force spectrum applied in the shock absorber fatigue test
