# Geotechnical modelling and subsurface analysis of complex underground structures using PLAXIS 3D

In this study, analysis of complicated underground structure of Horemheb tomb (KV57) at Luxor, Egypt by using the software PLAXIS 3D is adopted and the deformation that occurs in the body of the underground structure after applied the failure load detected; the failure loads are obtained from the series of laboratory tests. Then, the structure is modelled by using finite element code to perform accurate three-dimensional analysis of deformation and stability in complex geotechnical engineering and rock mechanics. These underground monumental structures have been analyzed by finite element method FEM to obtain the deformation that accrued into the structure and so beneath of the surface and calculated the effective stress, shear stress and horizontal displacements. In order to modeling requires the soil parameters obtained from laboratorial tests. In the analysis elastic-plastic Mohr-Coulomb model is used as material model. It involves five parameters namely, Young's Modulus (E) and poisson's ratio ( $\nu$ ) for soil elasticity, friction angle ( $\phi$ ) and cohesion (c) for soil plas

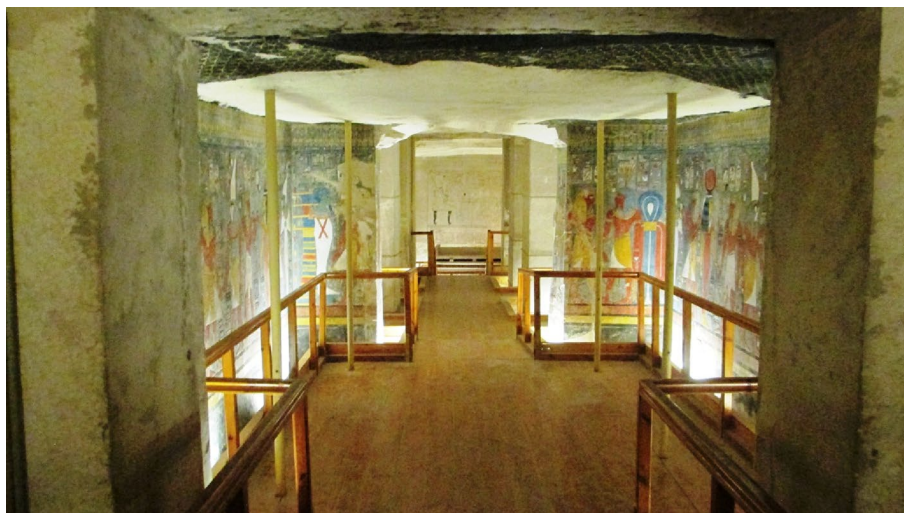
**Fig. 1** In-plane deformation patterns of the ceiling and walls like vertical cracks and crown zone rock falling and intensive cracking due to over loading (geostatic loading) and impact of old and modern flash floods in particular the 1994 flood

Figure 1 represents some in-plane deformation patterns of the ceiling and walls like vertical cracks and crown zone rock falling and intensive cracking due to over loading (geostatic loading) and impact of old and modern flash floods in particular the 1994 flood. Extensive structural damage of crown ceiling zones and engineering failure of the structural pillars, sidewalls and Ceiling of the Corridors and Chambers in the KV57. Brittle rock, high stress conditions lead to rock bursting (the sudden release of stored strain energy) bursts manifest themselves through sudden. Extensive rock falls from the ceiling is obvious and cracks are active. Carved and decorated walls in massive Esna shale Member are in advanced state of disintegration. The ornamented plaster on top of the chert lenses and nodules was damaged during the first flash floods that entered the tomb some 3000 years ago. During several restoration projects over the past 200 years,

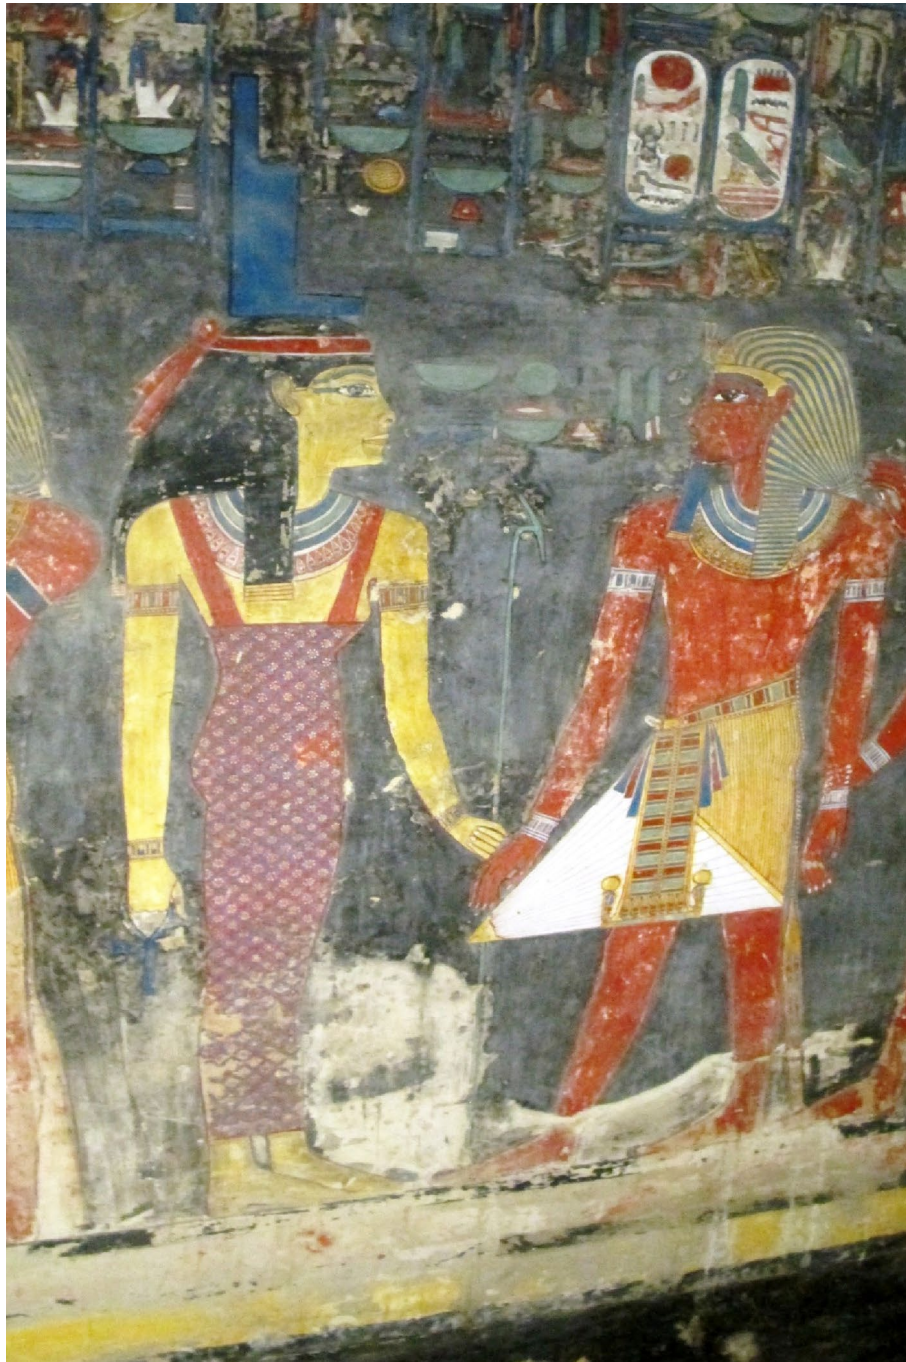
**Fig. 2** Carved and decorated walls in massive Esna shale Member are in advanced state of disintegration. Showing chert lenses. The ornamented plaster on top of the chert lenses and nodules was damaged during the first flash floods that entered the tomb some 3000 years ago. During several restoration projects over the past 200 years, cracks were filled with plaster for protection and stabilization of the tomb. The impact of the 1994 flash floods on the mural paintings inside the tomb are severely obvious

cracks were filled with plaster for protection and stabilization of the tomb. The impact of the 1994 flash floods on the mural paintings inside the tomb are severely obvious, as shown in Fig. 2.
