ANATOLICA 41 (2015)

PHASE I

The Terraces

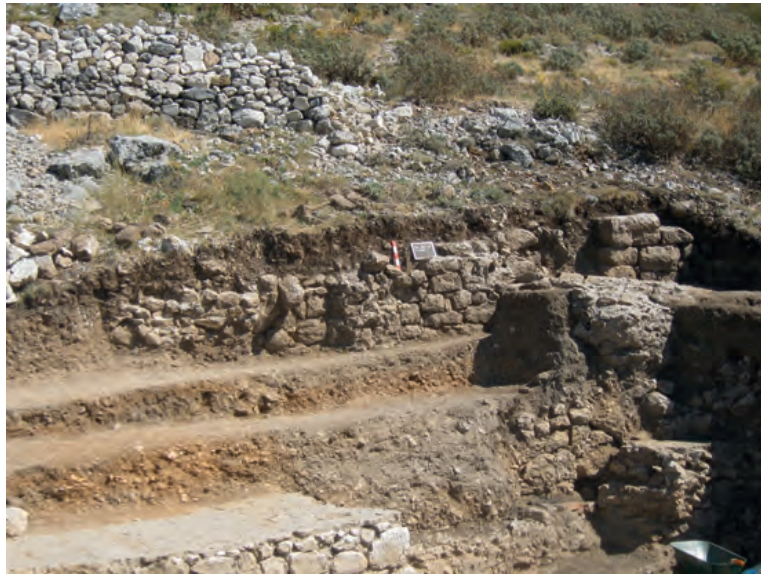
Fig. 2. (Terrace) walls of the original building phase at Site LE.

To the north of the back wall of the later public building, two walls formed part of an earlier building and/or terrace wall(s), within the recent excavation area (Fig. 2). A very short stretch of N-S wall was preserved, which had not disappeared when the northern back wall of the later public building was constructed. The other, E-W wall was identified while cleaning the north profile of the trench. Its appearance and construction technique resembled the polygonal (terrace) wall found behind the Neon Library in 1993, and could possibly be its continuation. Because of the orientation and height of the section, this wall could only be traced over a length of 1.5m. The upper 1.2m still held some patches of a plastered substrate of grey mortar containing tile aggregate. The lower 0.4m was covered with 0.03m thick grey plaster.

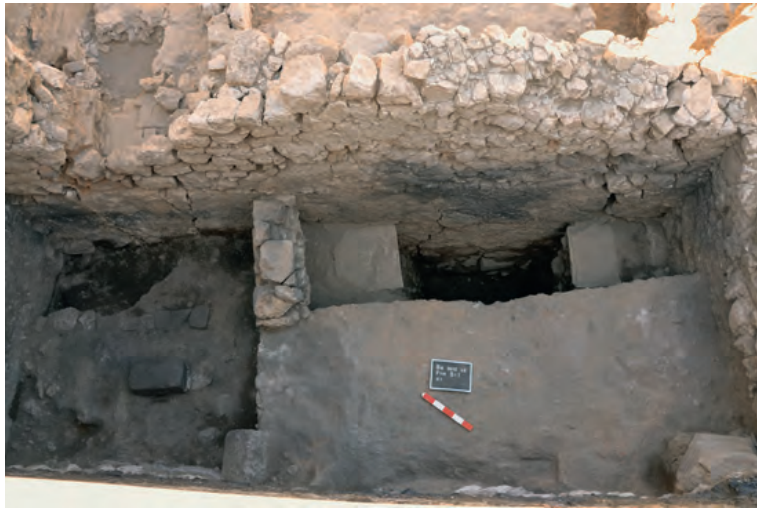
Fig. 3. View of the sounding in Room 1.

A sounding (0.8m wide and 3.3m long) was dug in Room 1, which was installed within the remains of the unidentified public building, alongside the southern part of its eastern wall, and cutting through its later Roman floor (Fig. 3). Bedrock could not be reached, but may have been close as many ophiolite clay chunks were present in the lowest layer. The entire stratigraphy was considered as fill, as no floor level could be identified. The pottery within the two lower fill packages was dated preliminary to the end of the 1st century BCE/early 1st century CE.

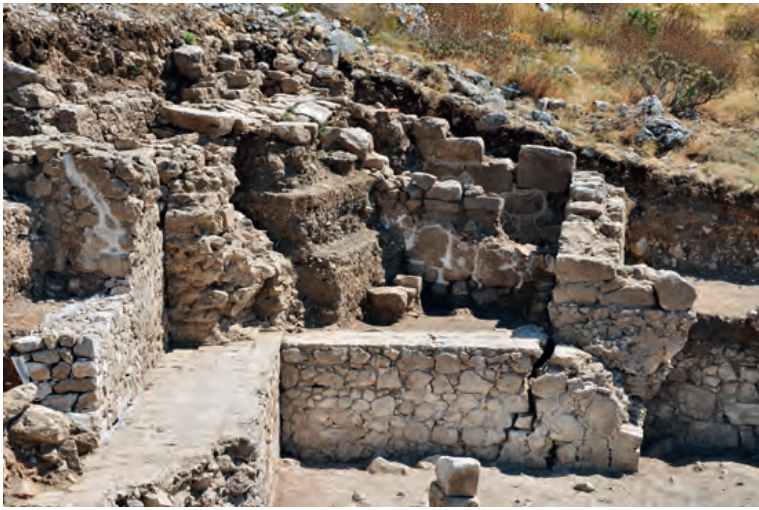
Fig. 4. Spaces 6 and 7.

Almost immediately underneath the topsoil and to the east of the later public building, two rectangular N-S orientated spaces were uncovered (Fig. 4). Space 6 measured *c.* 1.37m in width and Space 7 *c.* 2.5m in width. The northern limit of both spaces, which were probably rooms of a house, could not be determined, due to the later installation of an alley with water channel partially covering the spaces. Presumably Spaces 6 and 7 continued up to the terrace wall, which sustained an upper terrace house, of which Space 5 was partially excavated. Post-abandonment seismic activity or an unknown pressure from the East caused the southern common wall of Spaces 6 and 7 to shift 15 to 30cm to the West, pushing the sidewalls askew.

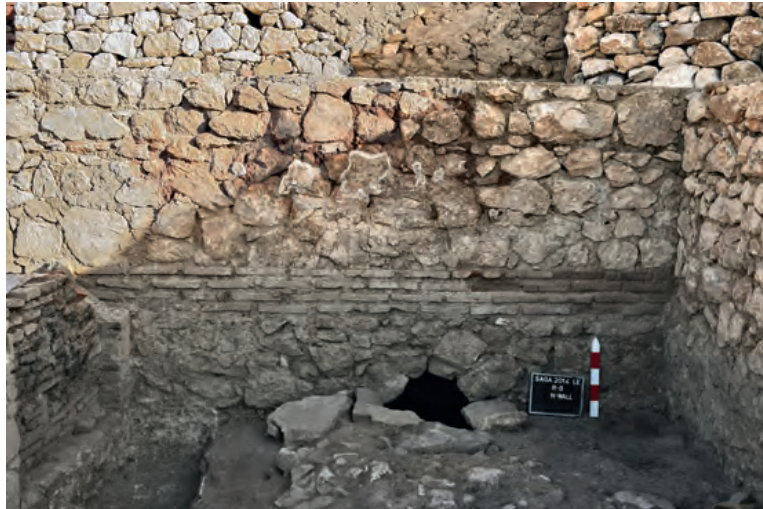
Fig. 6. *Opus vittatum* as used in the unidentified public building.

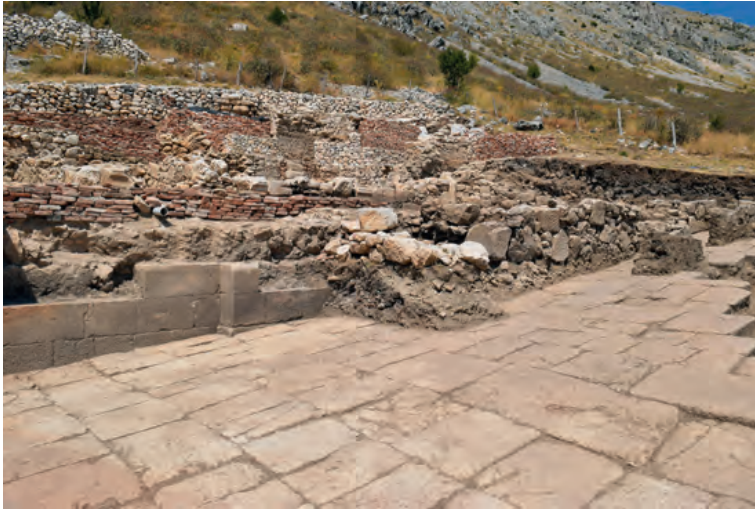
Fig. 7. The finely cut ashlars at the bottom of the support wall for the sidewalk in front of the public building.

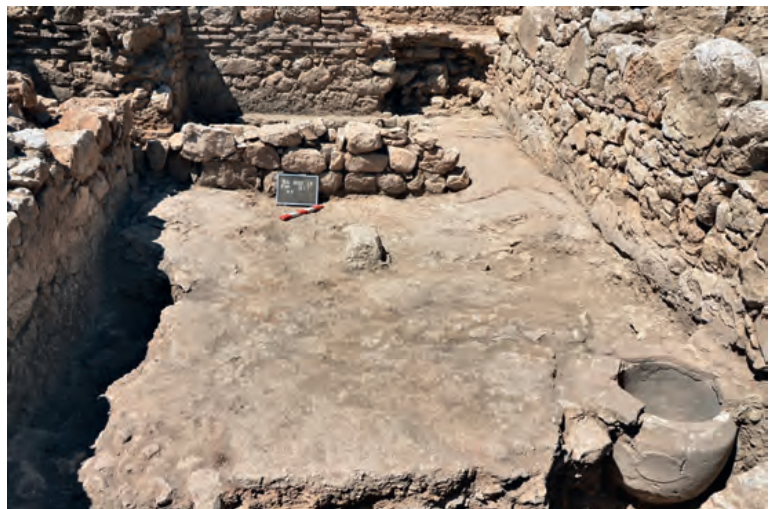
Fig. 8. The recycled stone vessel inserted into the floor of the central room of the public building.

In the front part of the central room, about 2.3m east of the eastern wall and 1m north of the southern façade, a round limestone vessel was installed into the floor. Its edge was covered with mortar and lined with tile fragments. The vessel had an outside diameter of 0.46m, was 0.62m high on the outside and 0.48m deep. The inside surface was worked smooth. A sounding was made between the vessel and the southern façade revealing that the stone vessel formed part of the original floor arrangements of the public building (Fig. 8). The vessel itself was cracked, chipped and broken in places, meaning it was given a next use-life as part of the unidentified building.

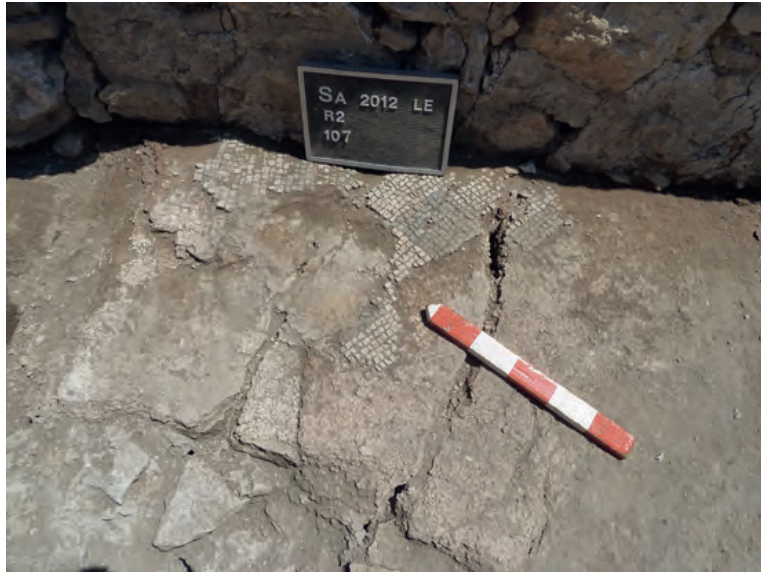
Fig. 9. A preserved patch of floor mosaic in the central room of the public building.

The importance of the central room was further stressed by its mosaic floor, which was largely removed in later Roman times. Small patches of mosaic were found in the NE corner of the later Room 2 and underneath its partition wall with Room 4 (Fig. 9). The level of the

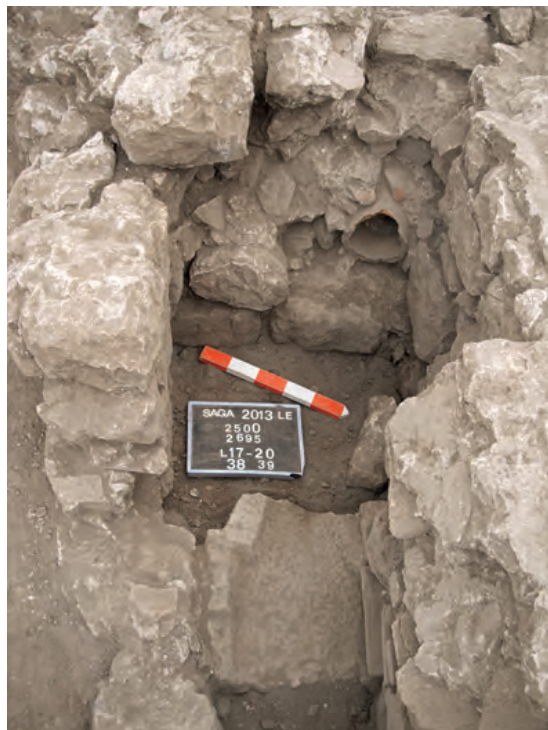
Fig. 11. The upper part of the shaft channelling the water to a lower level.

The bottom of the shaft was reached at 4.35m below the top of the gutter stone. The shaft connected here on its SE side into a beehive-shaped water channel, running underneath the east side room of the public building. The fill of the channel was not excavated for safety reasons: the cover was damaged or had collapsed at several points. Near the start it was possible to expose a small part of its intact floor. Here, the floor had a slope of

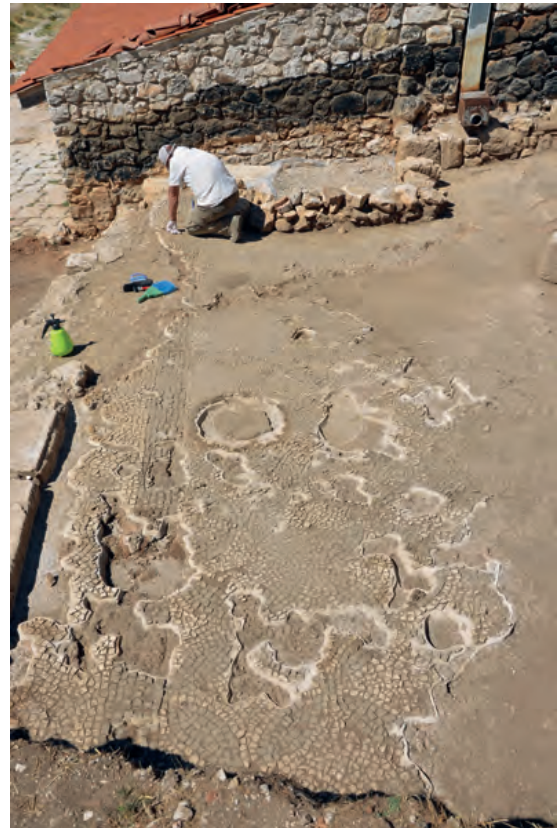
Fig. 12. The mosaic floor panels of the sidewalk.

Only in the western half of the sidewalk, the composition of the mosaic bedding was still recognisable. In the south and west the mosaic was bordered by a fragmentarily preserved broad band of irregularly placed white *tesserae* (R 1y). Within this frame a less broad band of black mosaic stones (R 1y – 6 *tesserae* wide: 0.20m) enclosed the central pavement area on all sides (partly preserved in the north, west and south), while a similar band subdivided the zone into separate

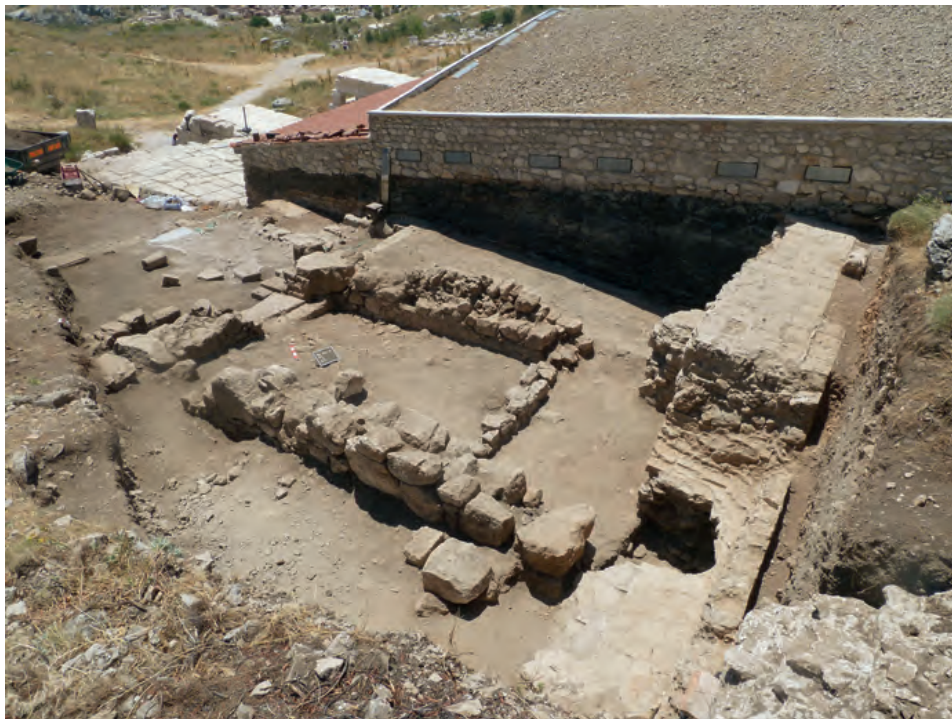
Fig. 14. The dismantled masonry of the northern back wall of Site LE.

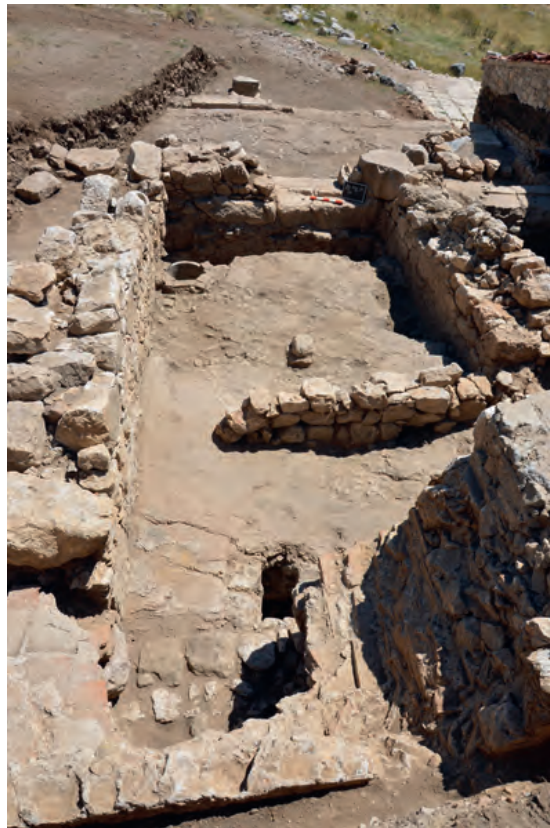
Fig. 15. General view of Room 2.

Room 2 (6.5m by 3.7m) (Fig. 15) was created by the addition of a division wall, built on top of the mosaic substrate in the former central room of the unidentified public building, in the course of the 5th century CE, or possibly already late in the previous one. The wall consisted of mortared limestone rubble with a coating of mortar, and some grey plaster patches near the bottom. The room was accessed from the south, through a reduced door opening of 1.1m wide, created by the addition of a dry wall of limestone rubble and spolia, including an architrave/frieze block, on top of the threshold of the façade of the former public building.

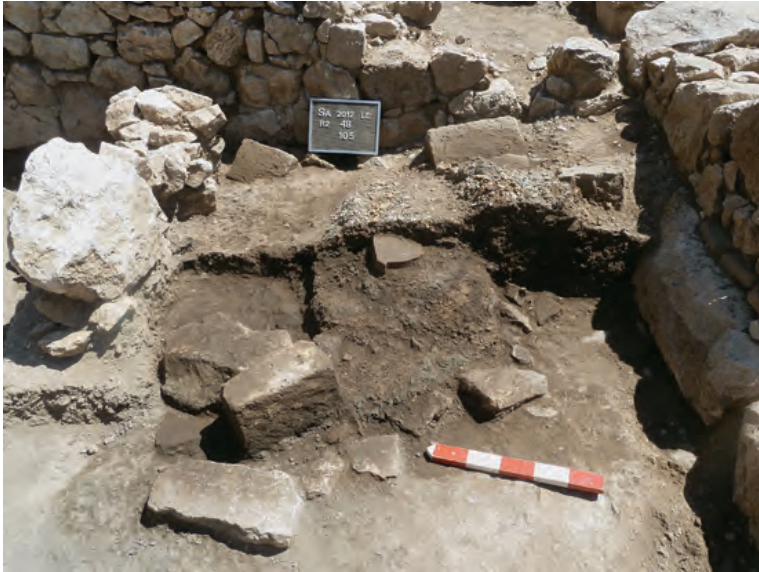
Fig. 16. The heating infrastructure in the southern part of Room 2.

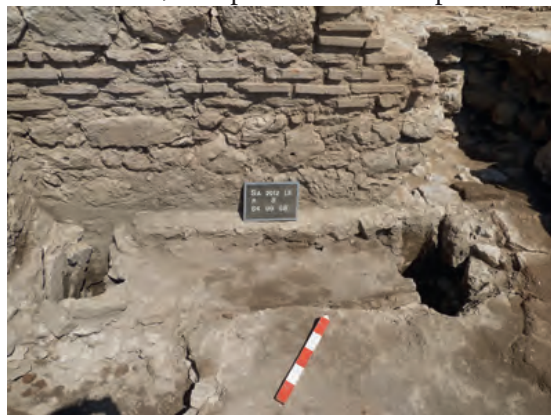
Fig. 17. Negative traces of the wooden installation against the back wall of Room 2.

Room 2 is preliminary considered as a small-scale production unit. The wooden installation in the back space could have been a vertical loom, for heavy items such as curtains or carpets. Alternatively, it could also have been a standing press, to fold washed garments and textile. Visual depictions of looms and frames related to textile working come to mind, as documented by L. Larsson Lovén (2001: 48-49) and P. Walton Rogers (2001: 158-161). In any case, the amount and variety of arte- and ecofacts within Room 2 is very limited, which seems to exclude its functioning as a house, but which, at the same time, hampers further interpretation. Finding parallels for the wooden installation will prove crucial. Possibly, the vats and the heat installation in the front space could also be related to textile washing (and/or dyeing?), facilitating the rinsing of stains (and the fixation of pigment?). These would not have been large enough for the worker to stand in them, but pieces of textile could be manipulated in these nonetheless. Vats are also a regular feature in tanning (van Driel-Murray 2001). On the whole, this workshop is not equipped as the much discussed *fullonica* of Pompeii, for instance (Flohr 2013: 96-180),

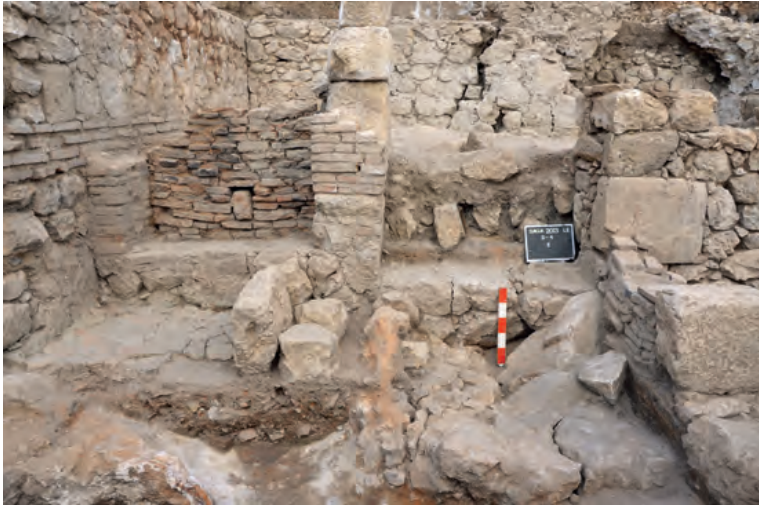
Fig. 18. The recess in the northern part of the east wall of Room 4.

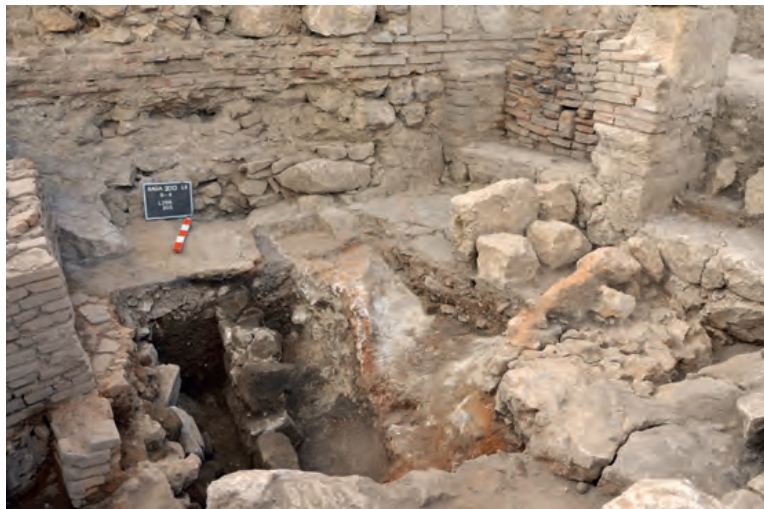
Fig. 19. The limekiln in the northern part of Room 4.

In a first period, a limekiln was constructed over the foundation of the removed internal wall of the former public building. The limekiln was located to the NW of the door opening between Rooms 4 and 8 (Fig. 19). It could only be partially exposed, as, in a later stage, a floor of brick fragments and a wall were constructed over its badly preserved remains. Only the lowest part of the structure was preserved, being its bowl-shaped floor (width: *c.* 1.3m, preserved depth: *c.* 0.38m), smeared with a layer of clay, which had turned red-brown as a result of the kiln's heat. The kiln opened towards the SW, sloping into a pit. The clay floor was partially lined with lime (max. thickness 0.07m). This feature was no recycled potters' kiln, as attested elsewhere at Sagalassos and also at Site LE, but purpose-built (for comparable structures and *modus operandi*, see Uschmann 2006 and Adam 1994: 65-73). The pit into which the limekiln opened also held a 0.03m thick layer of lime, and could have been used to hydrate or slake the

quicklime. This pit (length: *c.* 2m, width: *c.* 2.67m, max. depth: *c.* 0.84m) was bordered by a large stone (with lime attached) in the south, the foundation of the removed internal wall in the east, the northern back wall in the north, and continuing up to and beyond the west wall of Room 4. A small wall, of mortared, medium-sized limestone rubble and tuff blocks, was built in the bottom of the pit, connecting the northern back wall with the large stone in the south (length: *c.* 1.9m, width: 0.1-0.2m, height: 0.54m). The bottom of the pit was hard with small limestone fragments and lime. Only a small area was available to expose the pit as, in a later stage, a potters' kiln was built into it. The fact that the division wall between Rooms 2 and 4 was partially built over the pit, indicated that it was built relatively later. The western edge of the pit was located underneath the wall, as it was not visible in Room 2. Possibly, in the earliest stage of the re-arrangement of former public building, its central room was still used as such for a while. On the other hand, the limekiln could possibly also be related to the renovation process itself, producing lime for mortars and wall plasters, and the new division wall built as one of the final interventions.

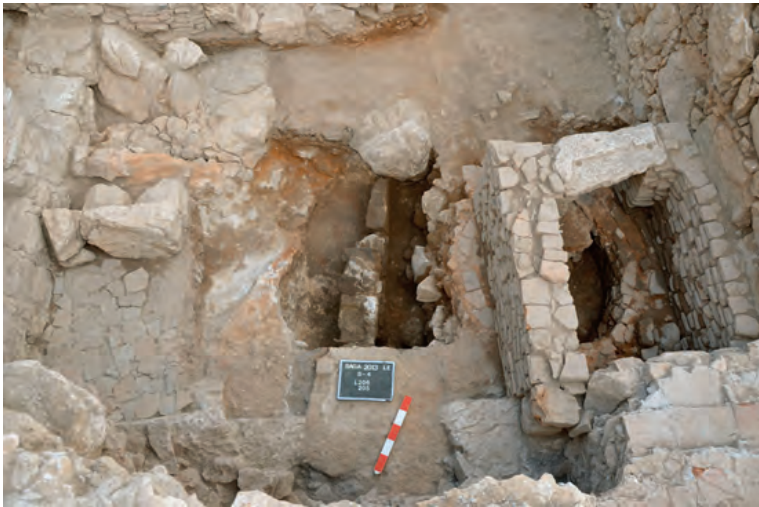
Fig. 21. The potters' kiln in the NW part of Room 4.

The latter floor was not found in the central area of the northern part of the room, corresponding to the front side of two kilns in this location. The first potters' kiln was constructed into and over the lime slaking pit, in the NW corner of Room 4 (Fig. 21). The backfill inside the pit, on top of which the kiln was erected, could be dated to the late 5th/early 6th centuries CE, suggesting that this and the previously discussed potters' kiln were most probably sequentially and not contemporaneously in operation. Only the lower part of the firing chamber of the circular kiln in the northern part of the room was preserved, with an opening (inner width: 0.37m) oriented towards the southeast, and a bottom of light grey (volcanic) sand with small limestone pebbles. A quarter of the kiln could be studied, as a younger rectangular oven was built on top of it, obstructing further excavation. The updraft kiln was lined with 10 layers of brick fragments (preserved height: 0.38m) and had an inner diameter of *c.* 0.9m. The bricks and outside were smeared with mud which had turned red-brown from heat radiation. Small to medium-sized limestone rubble was used as outer shell. The kiln showed no evidence of final re-use as a lime kiln.

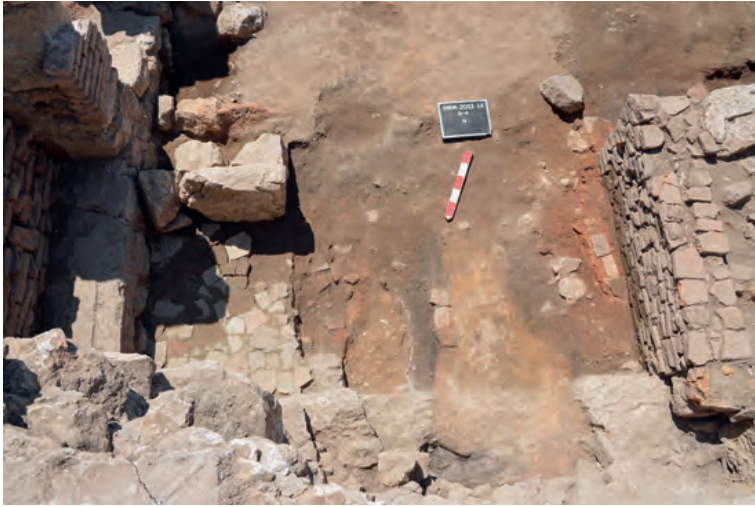
Fig. 22. The badly preserved remains of the potters' kiln in the northern part of Room 4.

Adjoining the latter kiln to the east, the very badly preserved remains of another potters' kiln were identified (Fig. 22). Apart from the typical discoloured zones outlining the silhouette of the kiln (diameter: 0.55m, length: 1.2m), the only structural evidence was a stretch of six consecutive brick fragments lining the lower part of the firing chamber on the east side, and the fact that a cut was made in the northern back wall of the room to accommodate the back of the kiln. The opening of the kiln (width: 0.3m) was oriented towards the southeast. Below the 0.01m thick, volcanic sand floor of the kiln a stratum of small limestone rubble was excavated. A dark grey/black, silty sand layer with plaster and charcoal outlined the structure. The kiln was installed into the mentioned second floor level, covering most of Room 4. Although

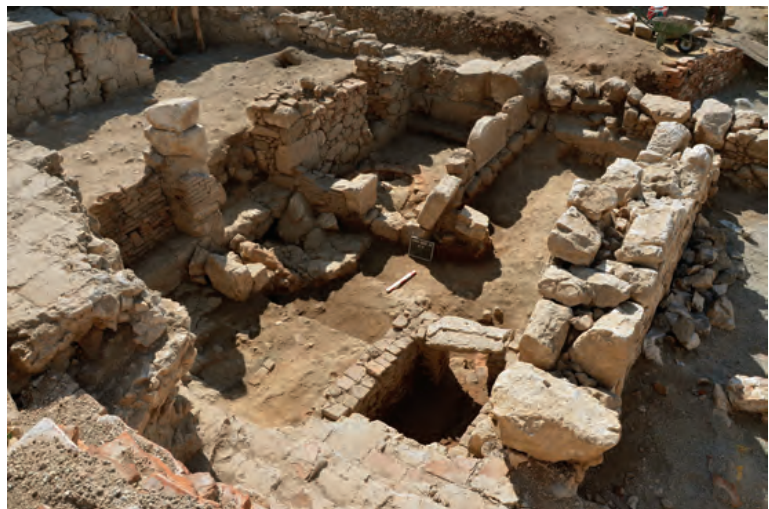
Fig. 23. General view of the re-arranged Room 4.

The west wall of the SE chamber (length: 3.25m) had a foundation of medium-sized limestone rubble. On top of that a narrow wall (*c.* 0.25m) of large spolia, brick fragments and small to medium-sized limestone rubble was placed. The wall was preserved to a height of 0.64m which is also considered as its original height. A door-jamb fragment was placed flat on top of the southern threshold of the former public building, continuing the line of this west wall. The SE room could be entered on the north side, via a door opening flanked by two rectangular limestone blocks. The threshold was made of small and medium-sized limestone rubble (width: 0.8m). Two

collapsed blocks found nearby could be related to the door opening. Between the door opening and the east wall of Room 4 a shelving unit was found (width: 0.89m, length: 0.53m, height: 0.45m). This unit of mortared, recycled brick fragments was partially constructed on top of the older foundation of the former public building. Up to eight brick layers were preserved. From the south side a specific build is recognizable. First, two layers of mortared brick fragments were placed, on top of which a more narrow section of mortared brick was placed. Upright brick fragments were also mortared against the south side of the upper part and a protruding support was created in the centre of the wall. We interpret this feature as a shelving unit, with two collapsed large tile fragments found just south of the unit perhaps representing the actual shelves. Another opening of 0.56m wide was noted in the east wall, which probably contained shelves as well. This shelving unit was accessible from both Rooms 4 and 8.

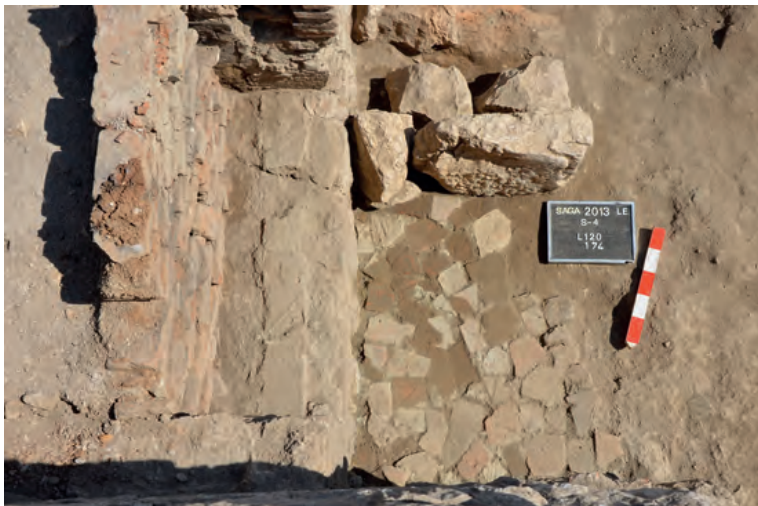
Fig. 24. The broken brick floor in the NE corner of Room 4.

In the NE corner of Room 4, in between the north wall, the recess in the east wall and a new, short south wall, a floor section (width: 0.95m, length: 0.85m) was laid out in broken brick (Fig. 24). Its western limit was less regular and stopped where the cut in the northern back wall started.

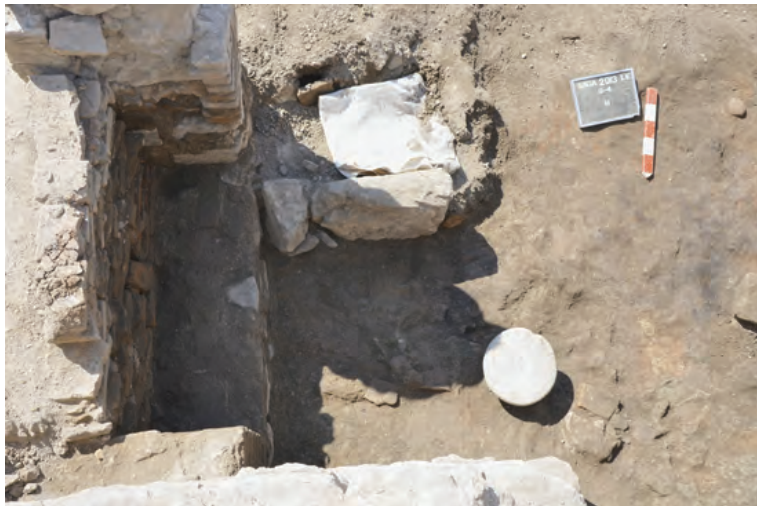
Fig. 25. Potter's turntable in Room 4.

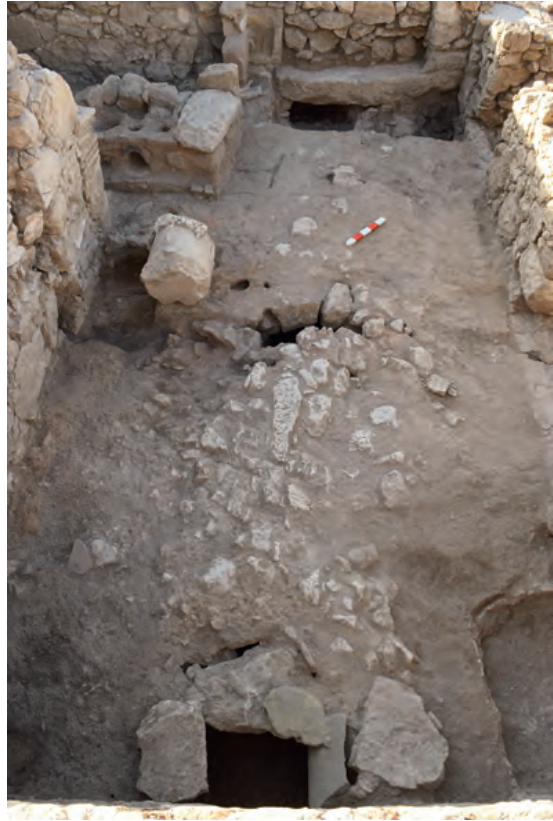
Fig. 26. General view of Room 8.

Room 8 was a large working space for the potters, and seems to have been used as such during the entire activity span of the workshop. The room measured 6.5 by 3.5m, with a vault-

ed extension in the southeast corner of 1.7 by 2.2m, and no internal divisions (Fig. 26). Its only point of entry was through Room 4. The room was abandoned with a lot of potting equipment still present. While Room 4 contained mostly oinophoros and oil lamp moulds, the excavation of Room 8 produced mostly stamps and several mould making tools in ceramic and metal. The bulk of these objects were retrieved near the edges of the room on top of the floor level related to the last phase of the workshop. Moreover, similar to Room 4, several objects were also found in the later fills/slope deposits, as though these finds only found their “final” position after Phase 4 or during the final abandonment and gradual collapse of the area. The green potting clay, and also a small amount leather-hard pottery, was found trampled into the floor, and also in larger piles near the corners of the room. This room also contained patches of the clay used for the slip covering the vessels in two locations: in the northwest corner and inside a broken vessel in the south central section of the room. Two more recycled column bases/potting tables were discovered: one on the floor next to the central part of the west wall and the other inside the partially collapsed water channel which ran underneath this room.

A small sounding of 1x0.8m in the southwest corner of Room 8, dug below the oldest 5th century CE floor level of the coroplast workshop, revealed a burned layer containing late 4th century CE pottery with fire-damaged 5th century CE material. Further research is required to establish the extent and nature of these layers, as these may hold the key to understanding the beginning of Phase 3.

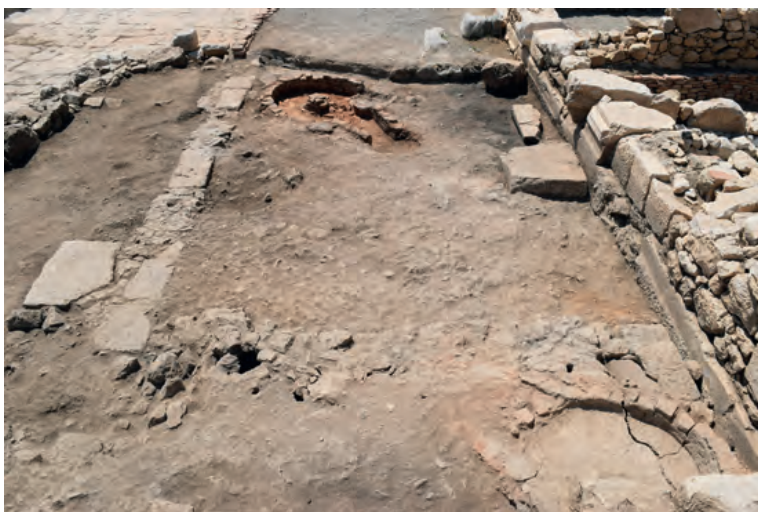
Fig. 27. The two youngest kilns of the coroplast workshop, installed on the sidewalk.

Only a few patches of the late Roman mosaic floor remained in the part of the walkway in front of Rooms 4 and 8. Actually, the remains of two potters' kilns were uncovered (Fig. 27), of which one was partially worked into the mosaic substrate. The kilns were presumably installed after the ones in the north part of Room 4 were put beyond use. A first circular kiln was installed in the southwest corner of the sidewalk area, directly into the mosaic substrate. Only the lower part of the firing chamber (inner diameter: *c.* 1.4m) and the central support of cut brick (height: 4 bricks, 0.17m) were preserved, with the flue (inner width: 0.7-0.4m, length: 0.71m) oriented towards the northeast. The remains of the updraft kiln were lined with 8 layers of brick fragments (height: 0.37m, width: 0.1-0.13m). The bricks and outer side were smeared with mud plaster, which had turned red-brown due to the kiln's heat. In its final stage, the kiln was dismantled, levelled and filled with a small pottery collection datable to the 5th century CE. A part of the kiln waste material was used to create a small ramp up to the threshold of Room 4.

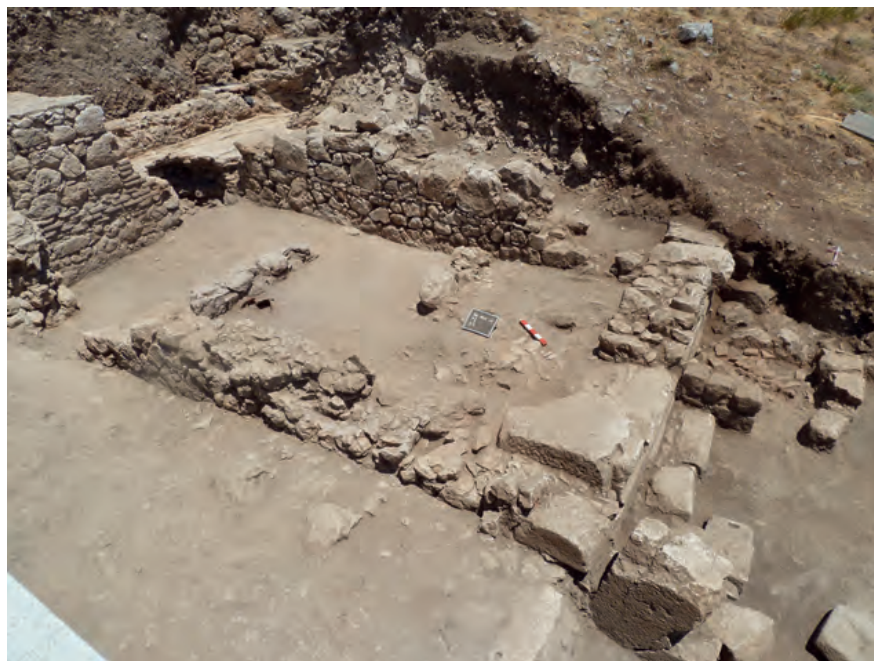
Fig. 29. General view of Rooms 1 and 2, Phase 4.

Both former rooms were connected with one another, by breaching their division wall. The rooms were still accessible from the sidewalk to their south, while the staircase connecting the latter with the lower sidewalk in front of the former Neon Library was narrowed by a simple limestone rubble wall. In this way, a new unit of three rooms was created (Fig. 29), connecting into one another, and with a wide (door?) opening on the east side, connecting with the newly arranged space extending over the east half of the former sidewalk. A small room was separated in the NE corner of the space created over the sidewalk. Due to slope erosion processes, most features were fairly badly preserved, disallowing, for instance, to conclude whether this new unit, or parts thereof, was still roofed or open.

associated with walking levels. The new floor level reached up to the height of the threshold in the southern façade. The ceramics in both levelling fills were dated to the 6th century CE. No finds could be directly linked to the floor level.

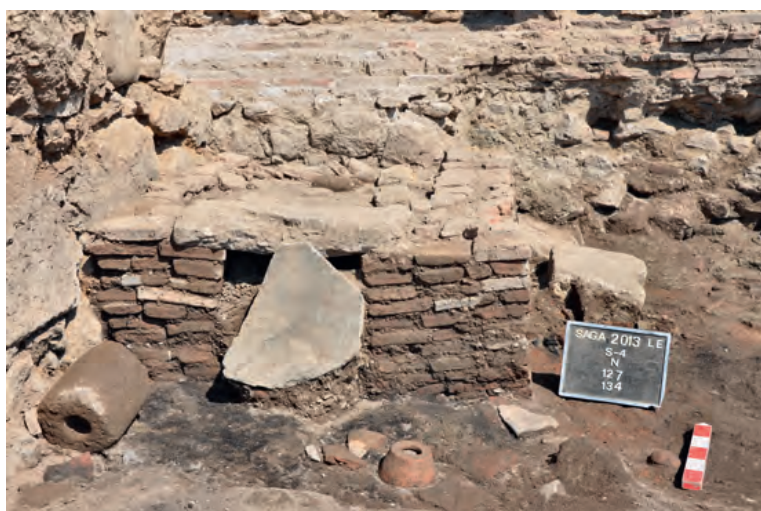
Fig. 30. The preserved lower part of the rectangular oven in Room 4.

In the same period, a rectangular oven (Fig. 30) was built over the remains of the potters' kiln in the NW corner of Room 4 and its backfill. Only the lower ash chamber was preserved (inner width: 0.87m, inner length: *c.* 1.22m, height: 0.74m). The oven used the northern wall of Room 4 as its back wall. The other walls were constructed with up to 13 layers of stacked half-bricks of various sizes. The sidewalls partially rested on top of the lower circular potters' kiln. The west wall was built against the division wall between Rooms 2 and 4. The trapezoidal opening of the ash chamber (width: *c.* 0.4m) in the southern wall was covered by a recycled doorsill (77x40x13cm). Charcoal was attested in the area of the opening. These remains were considered to originally have formed part of a bread kiln, of which the oven floor and arched superstructure were not preserved. Unfortunately, Roman bread kilns are not

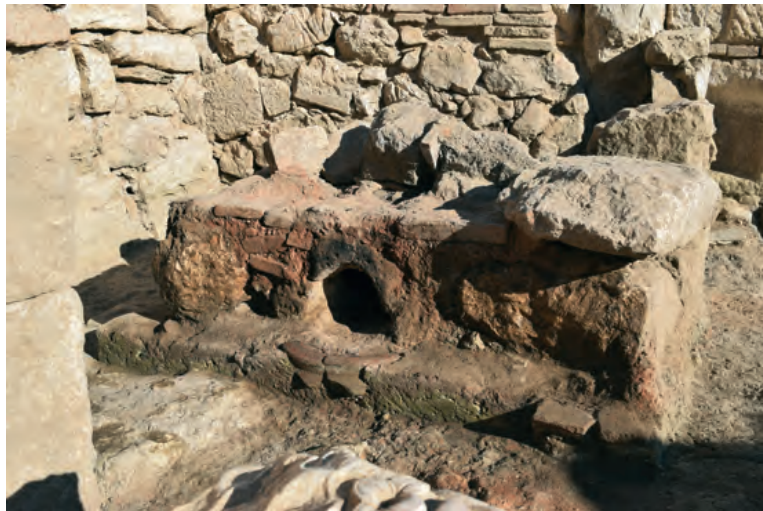
Fig. 31. The cooking set in Room 8.

The SE part of Room 8 was converted into a kitchen, featuring a stone mortar and a well preserved cooking set, partly installed in the arched niche in this corner of the room (Fig. 31). In order to create a level surface for the cooking set the green clay was re-arranged and more or less evenly spread in the area of the niche (thickness: 0.05-0.1m). In the area to the south of the feature (max. width: 0.9m), which is considered behind it, a considerable amount of mostly large fragments of the local table ware, datable to the second half 6th century CE, was found. A short N-S wall, made of brick fragments and spolia, contained a narrow doorway (width: 0.42m) from which this pantry(?) could be entered. In the area in front of the cooking set (max. width: 0.8m) nearly no finds were registered, while the soil was very compact (thickness: 3-5cm) and contained stratified ashes and charcoal, resulting from repeated cleaning operations.
