Energetic Refurbishment of Historic Brick Buildings: Problems and Opportunities

Jurgis Zagorskas¹, Gražvydas Mykolas Paliulis², Marija Burinskienė³, Jūratė Venckauskaitė⁴, ¹⁻⁴*Vilnius Gediminas Technical University*, Torben Valdbjørn Rasmussen⁵, ⁵*Danish Building Research Institute, Aalborg University*

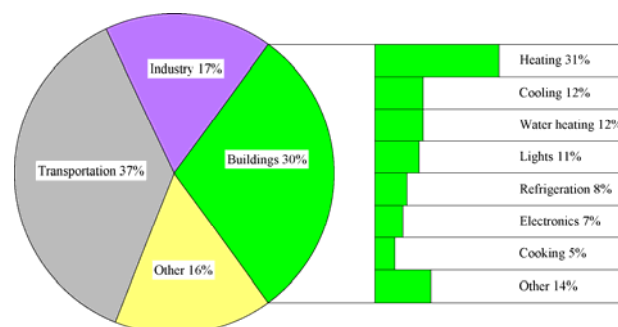
Fig. 2. Energy consumption in general and in buildings of European countries [22-24]

The energy consumption for heating and cooling the inside takes around 45% of the energy consumed in buildings (see Fig. 2). Other great energy losses happen in heating the water, lights and electronics, refrigeration and cooking which are not related to retrofitting directly, except the electronics where energy efficient bulbs and intelligent systems for saving electricity can be applied to cut overall energy use by 2-3%.

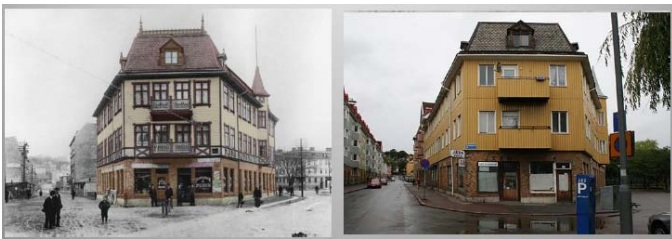
Fig. 3. Example of refurbished building when energy performance was increased to meet modern standards, but the authentic look of the building was destroyed.

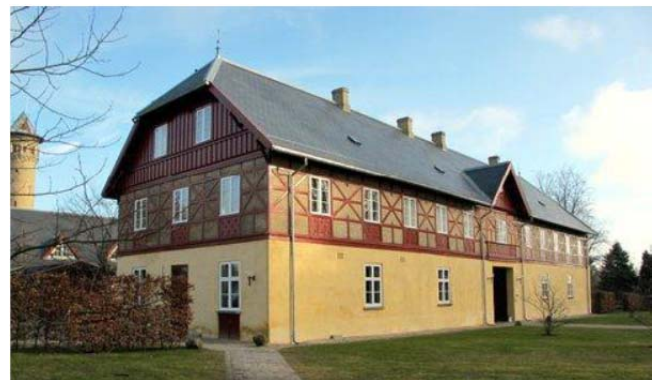
Fig. 5. Kavalergården building after refurbishment

One of the typical examples is the Kavalergården building refurbishment in the outskirts of Copenhagen, Denmark (Fig. 5). The building was constructed in 1877 as part of an architectural ensemble of the Bernstorff palace. Before recent reconstruction, the building had deteriorated and it was decided to renovate it and increase energy performance. Refurbishment works included change of roof tiling, roof insulation, use of modern lanterns, change of regular window glass to reflective glass, change of doors, and installation of an effective modern lighting system. According to theoretical calculations, the energy savings on heating should decrease by 22 %. The measurements done after one year of functioning of the refurbished building indicated that the energy savings were

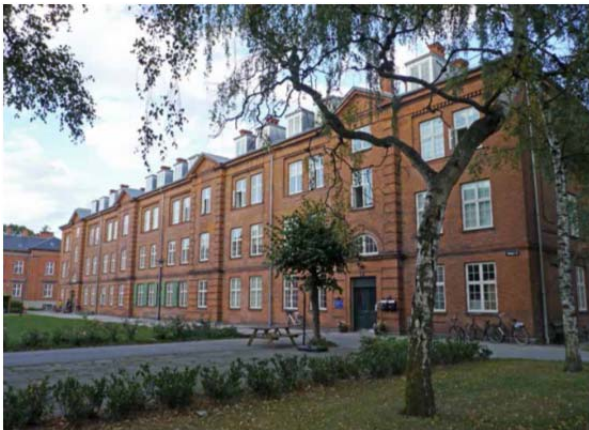
Fig. 8. Elmehuset building after refurbishment

Another example – energetic refurbishment of multi-flat house Emehuset in Copenhagen, Denmark (Fig. 6), when the main measure taken was insulation of outer walls and roof. The exterior of this former poorhouse in solid masonry, with

In the year 2009 it was concluded that the building needs renovation, the windows and plumbing needed replacement. Facades were considered valuable features of the building and it was prohibited to make outside insulation. The outlook of the building had to be kept the same to have the same style and appearance as the surrounding buildings. The building had G class of energy performance. The combined measures of roof insulation, changing of outside doors and windows, reinstallation of electricity cables, lighting system and plumbing, change of convectors and ventilation system, and inside insulation of outside walls in stairwells were applied. After refurbishment the building was certified for C class in energy performance.

There was a discussion raised when selecting the measures to be applied in this building. Consultants made calculations of energy benefits from each measure. Architects and engineers recommended internal insulation of facades with 200 mm mineral wool, which would fulfill the requirements of the Building Regulations, and that mechanically balanced ventilation was provided.

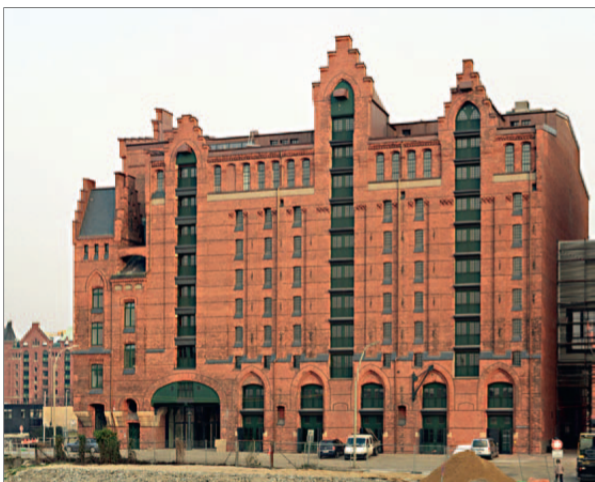
Fig. 9. Historic building reconstruction in Hamburg

Very often wall insulation is not applied in historic building energy refurbishment. Storehouse refurbishment in Hamburg (Fig. 9) to suit the needs of a museum and exhibition center provides such an example. The energy in this project is saved mainly by an innovative HVAC system. The building had masonry walls 80cm thick and more. In the basement there was enough floor space to install a modern HVAC system. Floor heating was installed in the ground floor. Modern windows with controlled air leakage allow air to come inside the building and as the air is heated it gradually rises to the roof through the central hall and comes out through the ventilation openings. There are infrared heaters on the ceilings on every floor working only when the room is in use. The cost of this reconstruction was 28 mill. €.
